2023 Installation Failure Cases

Service Operation Team 2023.12.13

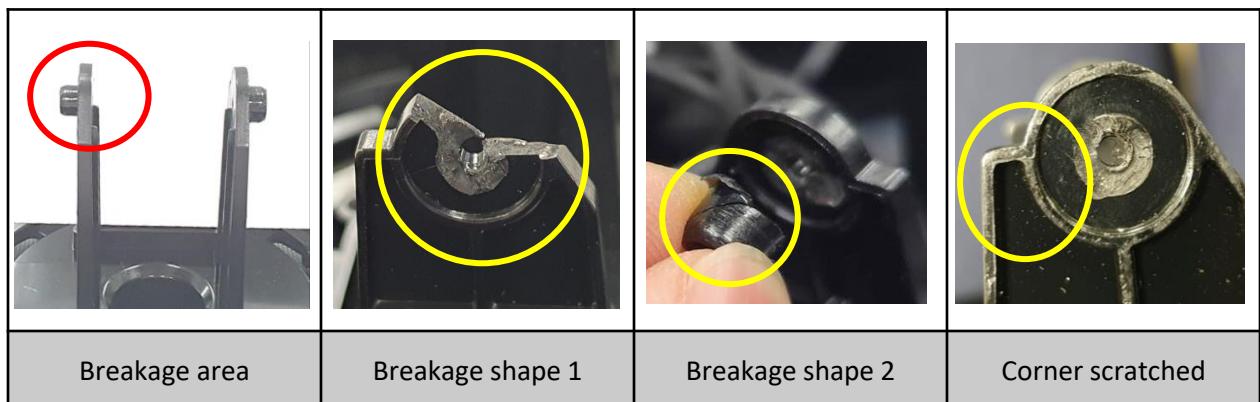
- The set angle of view is not maintained and keep tilting down looking at the ground

- Plastic unit which holds the lens was broken, thus the lens could not be kept at the set position
- It is estimated that external impact was delivered such as breakage due to torque overload or dropping down

- Use manual tools to prevent torque overload when bolting
- In particular, the fastening part where plastic and metal come into contact with each other is prohibited from using power tool

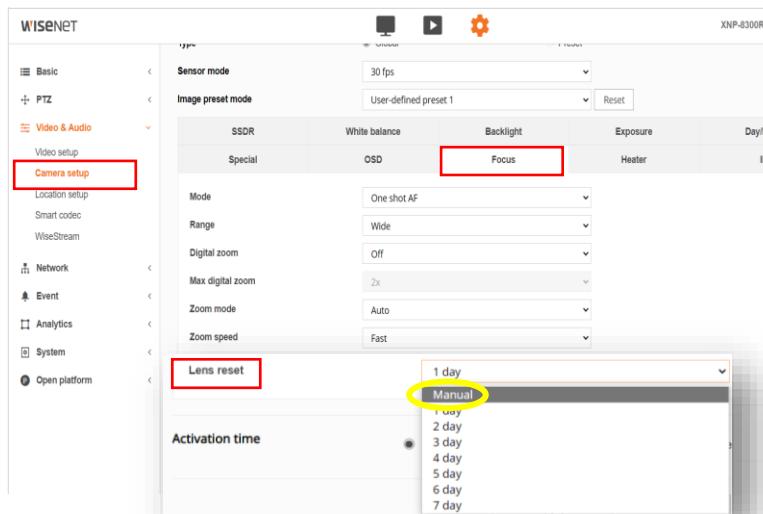
[Lens initialization setting Manual]

- Automatic lens initialization was set as 'Once a day'
- While performing lens initialization, it zooms in to max level thus one spot is enlarged too much so that the scene looks like showing only one color
- Video and Audio > Camera Settings > Focus > Lens Initialization

- Change the lens initialization option as 'manual' and perform the initialization at a time only when user wants

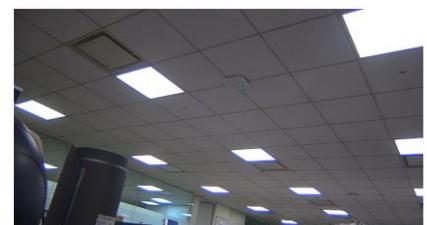
[Max. Zoom in]

- Camera automatically operates tilt down, zoom in/out, focus adjustment, preset movement at a certain time once a day
- The screen looks noisy and seems like showing one color

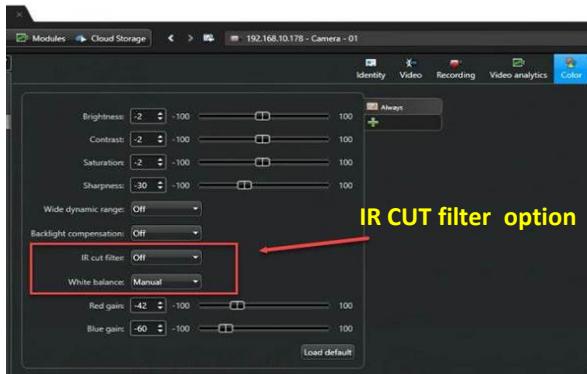
[Genetec: VMS IR Cut filter option]

- Camera color setting is forcibly changed to Color -> Auto due to 'IR Cut Filter' setting used by VMS linked to camera
- When using 'IR Cut filter,' it blocks infrared rays during the day to prevent color distortion and displays images that are close to the true color of the human eye view. However, when used at night or in low light condition, the image sensor cannot absorb enough light, which can cause the image to become dark and blurry

- If the image is displayed differently from the one set on the camera, check the camera setting including the 'IR Cut Filter' of the linked VMS

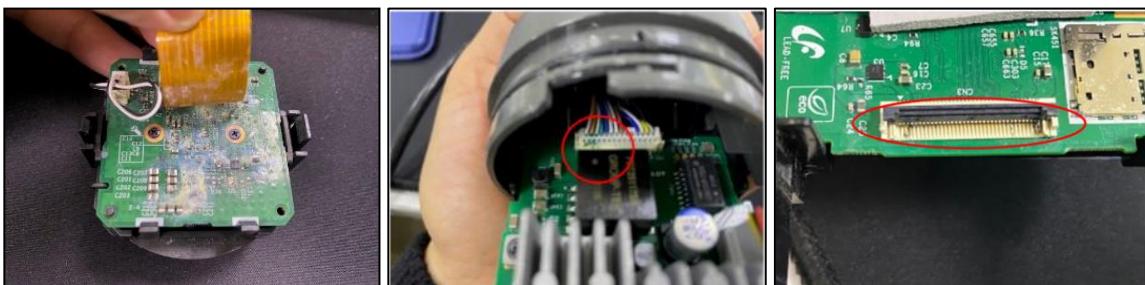
- Corrosion occurred overall inside the camera

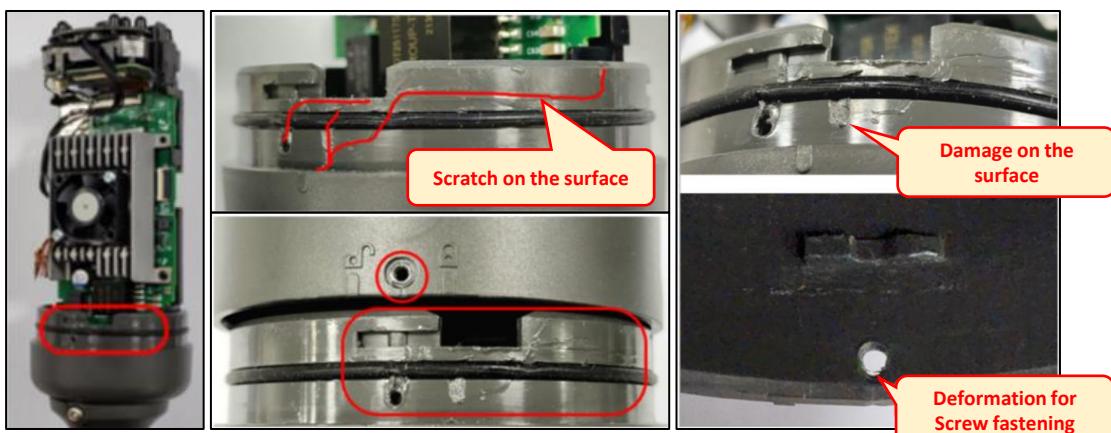
- Deformation of screw fastening parts and damage to the mechanical surface, resulting in moisture inflow and PCB corrosion
- Forced disassembly/assembly without removing screws fastened to the body

- When removing the body cover, be sure to remove the screw completely before disassembly
- Be careful not to damage the O ring nor make some crack on the screw fastening part

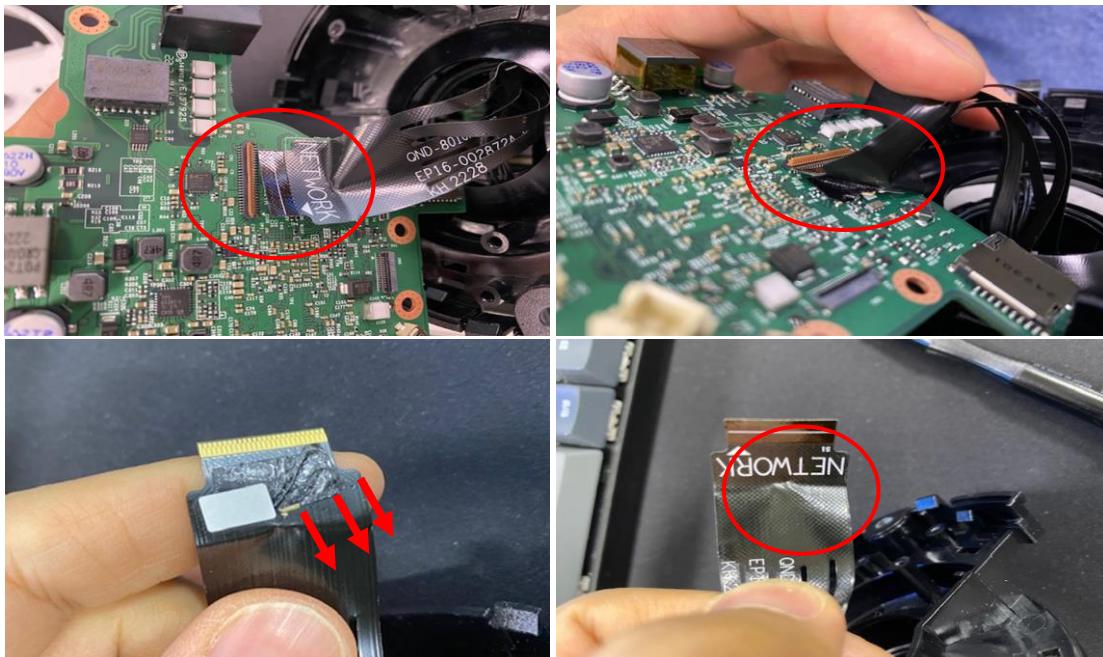
- FPCB disconnected which links between network board and sensor board
- Assumed that the lens was disassembled arbitrary for camera angle adjustment
- External force which is greater than the FPCB attachment strength was applied to the camera

- Do not disassemble arbitrary even if internal review of the camera is required
- When changing the angle of view, be careful not to change it forcibly to an angle beyond the allowable range

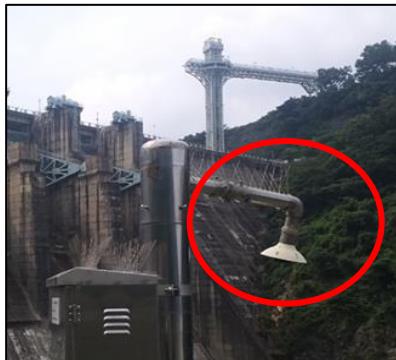
[Install as tilted angle]

- Purpose : Installed outdoor PTZ camera for dam water gate monitoring
- Environment
 - . Installed to a distance close enough to get waterdrops when gates are open
 - . In order to secure whole scene of the dam, the camera was installed as tilted

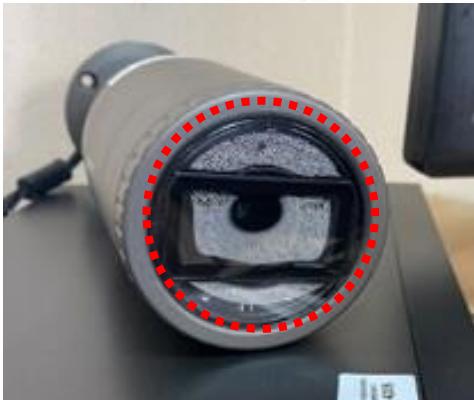
[Front glass moisture]

- Moisture appears repetitively on camera front cover even though Desikan has been replaced

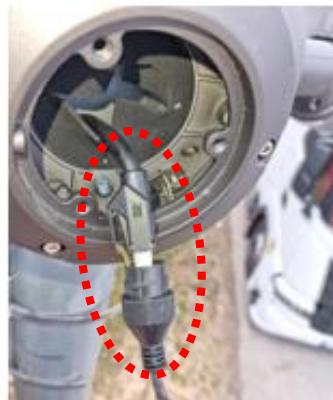
[Gasket & butyl tape missing]

- Unproper cable waterproofing work: Waterproof Kit, Butyl tape not applied

- Comply with the installation guide
 - . Apply RJ45 connector waterproofing Kit
 - . Apply butyl tape for waterproofing

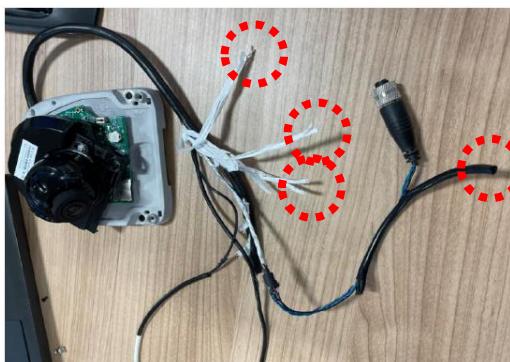
[Arbitrary cable cutting]

- Arbitrary device change: Cable cutting and cladding
- Damage to camera power supply part, short between cut cables

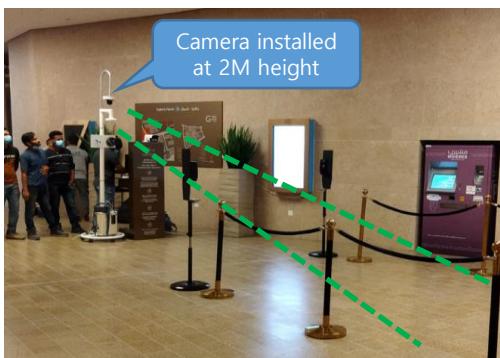
[Installation height]

- Camera installation location is too low and close to the monitoring area to obtain enough viewing angles. Objects entered the scene too large and interference the detecting line, causing people counting was not able to count correctly (before/after passing the sensing line is not clear)

- Comply with guideline : Online help AI page
- . Secure enough camera view angle
- . Avoid locations affected by strong light, such as sudden lighting changes, direct sunlight, sunsets, and sunrise
- . People counting purpose camera should be installed at ceiling

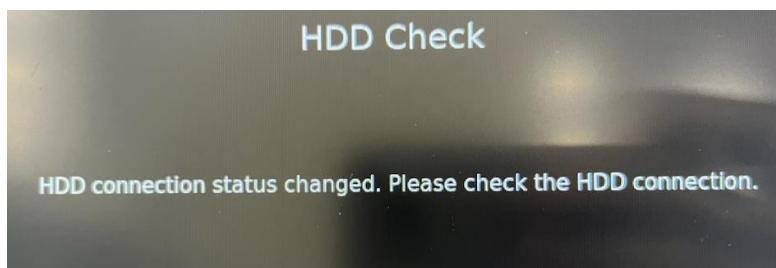
- Error pop-up "HDD connection status changed. Please check the HDD connection."
- Set up → Device → No HDD in the storage media list
- HDD recognition failure occurs after an unspecified period of time even if HDD is recognized and operated normally

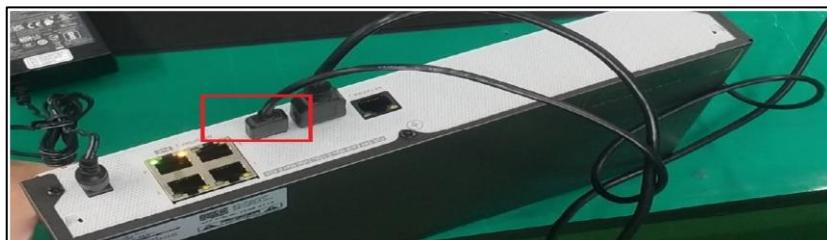
- Powering the external portable monitor by connecting from the rear USB port of the NVR
- The power consumption of the portable monitor exceeded the USB power specification of the NVR
- Portable monitor : 15W (DC 5V, 3A) // NVR USB(2.0) : 2.5W (DC 5V, 0.5A)
- When powered to an external device, HDD malfunctions due to insufficient current when driving the HDD

- Do not use the NVR USB port other than mouse or external USB memory

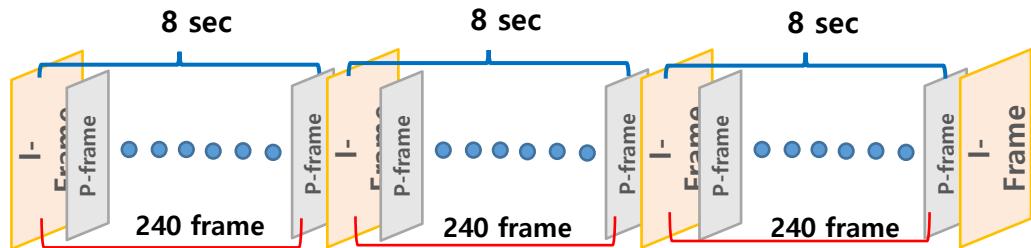
- Setting the GOV length **(240)** without considering fast playback specification
(Only plays I-frame at fast playback)
- GOV length 240 = I-frame 1 + P-frame 239
- **If frame rate is 30fps and GOV length is 240, I-frame is received at every 8 secs**

- Adjust the length of GOV to not to skip scenes even playing back at fast speed
- As the length of the GOV becomes shorter, the number of transmissions of I-frames increases. NVR setting is required considering the frame rate, storage space, bandwidth, etc. of the site (Recommended: frame rate 30fps, GOV length 30~60)

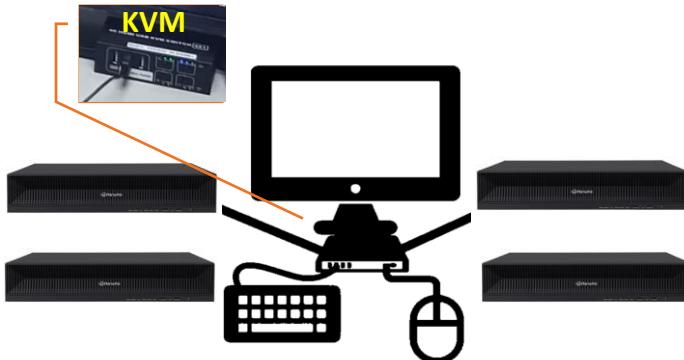
[Site configuration using KVM]

- 4 NVRs are connected to KVM using HDMI connection, and the user controls all 4 NVRs via KVM
- KVM switch is not compatible with our products, and can not be used together

- Remove KVM switches and set up individual connection to monitors for each NVR
- Pre-check compatibility between devices before installing on site

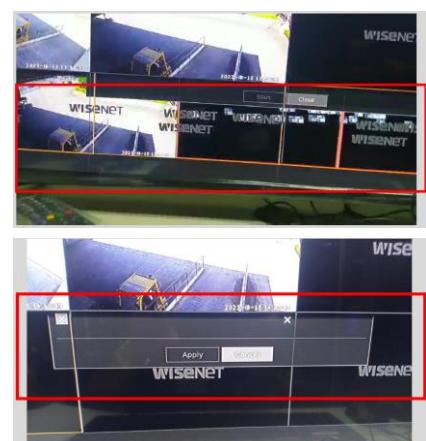
[Abnormal video display]

- When switching NVRs in SSM, some NVRs experience switching speed delay and displays abnormally
- Mouse cursor disappears and NVR can not be controlled

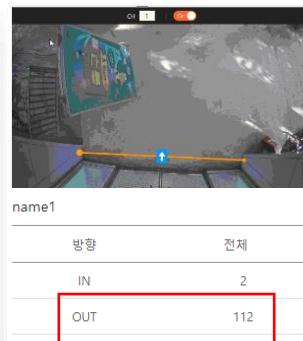
Cause2. OMA is not running, app and camera counting information was not initialized when setting is changed

[Camera P.P. counting IN(+2) + OUT(-112)/
Total sum is - value, OMA app does not count]

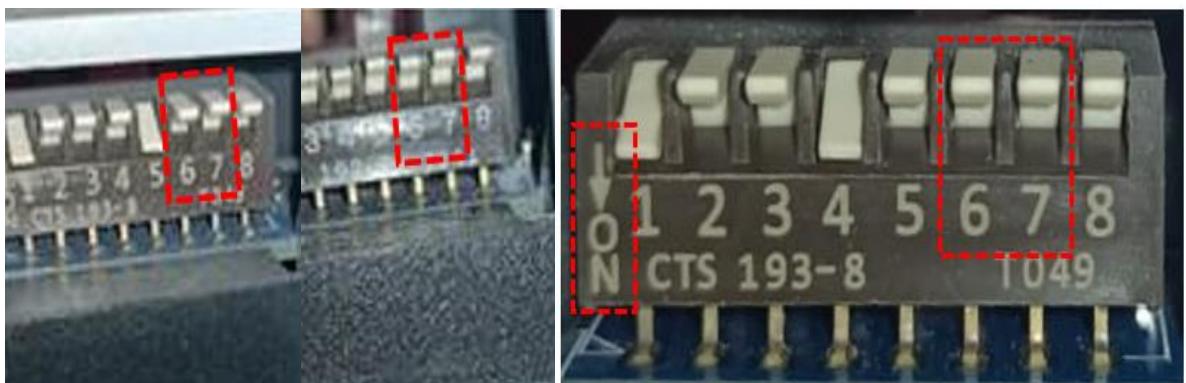
- Confusion of the controller switch direction, communication speed setting error
 - . Up ↑ : switch off, Down ↓ : switch on

[#6, 7 DIP switch off : Not recommended]

- Apply recommended WACS setting value, and be careful for DIP switch 'ON' direction
 - . Baud rate : 38,400bps
- Refer to the product User manual
