Aug. 2023

Technical Newsletter

Aug. Contents

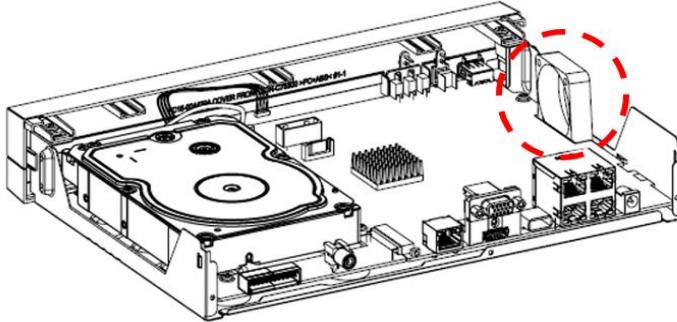
- To eliminate fan noise and A/S claims regarding the fan, the fan is removed from one HDD NVRs

[Before : Fan embedded on the left side]

- (1) **Remove fan and update F/W(MUST!)**

: Functions remain the same but only removed fan alarm feature

. Fan connector is removed from new mainboard

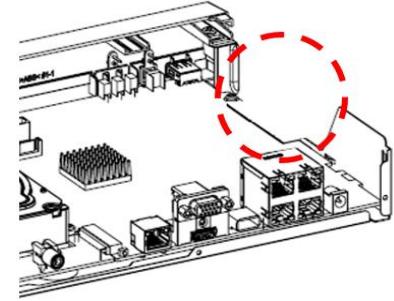
[After : Fan removed]

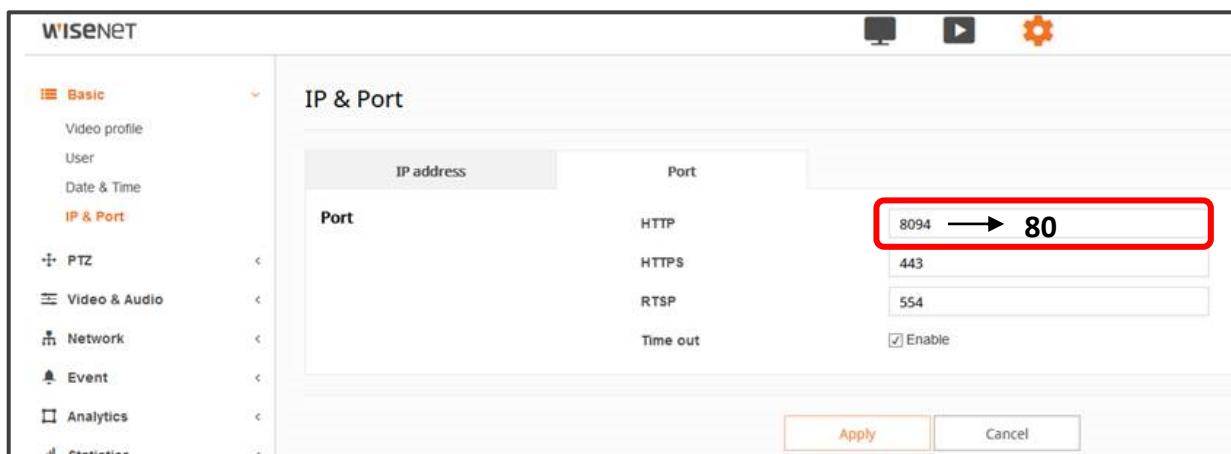
- Reason for HTTP 80 port setting
 - . Device Certificate Agent S/W is developed as to work at HTTP "80 port"
 - When inserting device certificate, it links to its HTTP port by using SUNAPI protocol
- Setting guide
 - . Check if the device's HTTP port setting is '80 port'
 - . If HTTP port is different than 80, it needs to be changed as 80

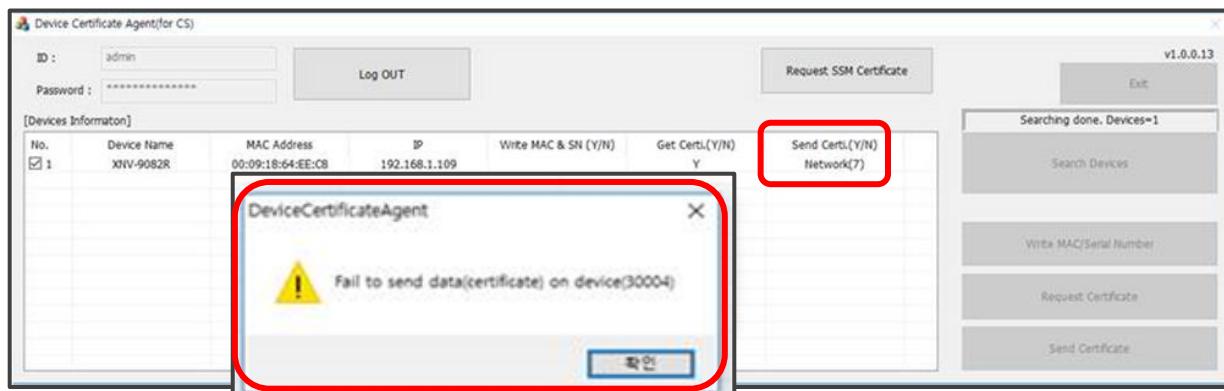
3. Network(7) error occurs if HTTP is not 80 port

- . Network(7) error occurs with "Fail to send data(certificate) on device(30004)" message pop-up
