Installation failure cases in 2024

Service Operation Team 2024.06.30

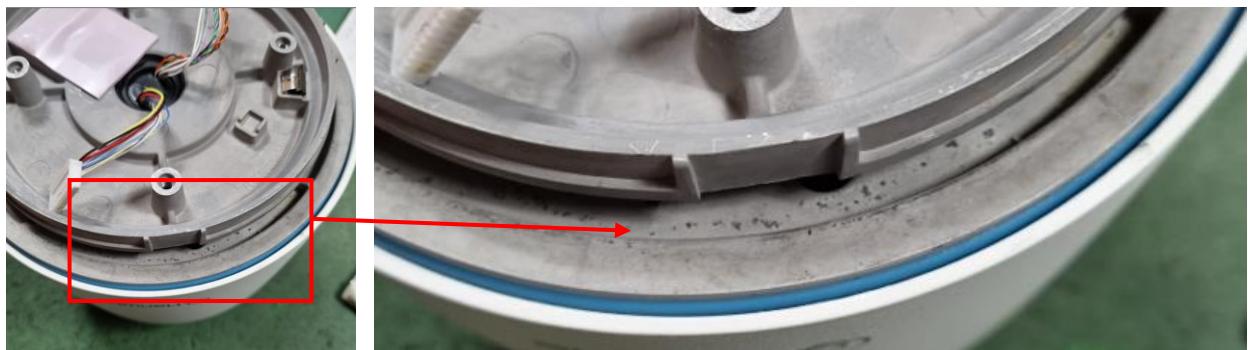
- When disassembling cameras which couldn't be turned on, traces of water leaks were found in the camera bodies.

- Water couldn't be discharged from the PAN rotation bearing part due to a camera installed in the reverse direction, which made it difficult to guarantee its waterproofing. As a result, water remained in the part.
- The waterproof and dustproof rating of XNP-9250R is IP66 (spraying water, dripping water)
- Protection against water not discharged is guaranteed with IP67 (immersion), not with IP66.

- It is recommended to install the camera in the correction direction.
- The reference point for product installation is the logo printed on the product, which must be displayed properly as shown in the photo below.

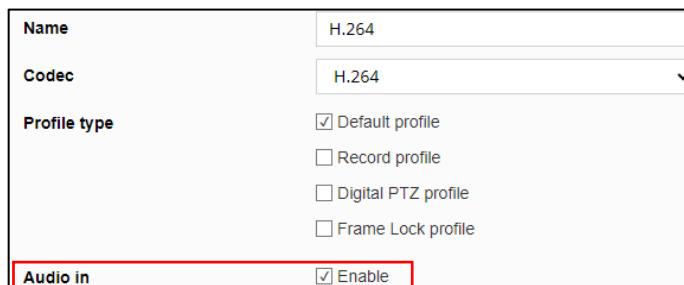
- Rebooting the system after changing the camera setting to use audio (enabling the 'Audio in' option in the profile)
- The 'Audio in' option became unchecked after reboot.

- When the system rebooted after changing the camera settings, the settings of the last connected device (NVR/SSM, etc.) were retrieved in the process of restoring the settings. As a result, the problem of setting cancellation occurred.

- (1) Refer to the path below to first enable the audio use item on the storage device, then
- (2) Then enable the audio input item for each camera profile.

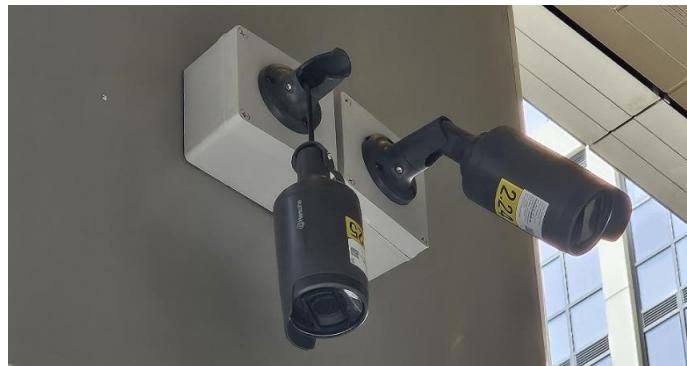
- There was a risk of the camera falling due to damage to the joints of its rear assy within 1 month after its installation.

- Use manual tools to prevent torque overload when tightening bolts.
- In particular, do not use electrically-drive tools to secure areas where plastic and metal meet.

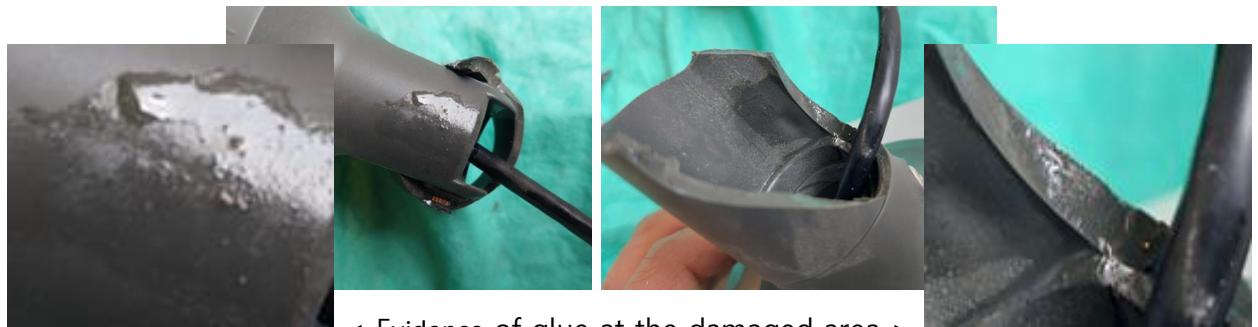
- Cracks caused by fastening the fixing screw with an electrically-drive tool.
- Cracked products randomly repaired and installed with instant adhesive.

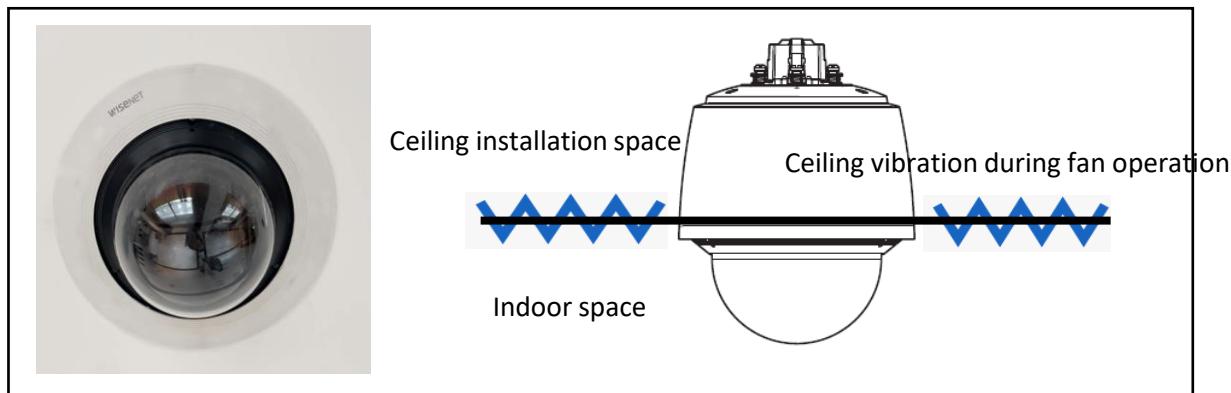
< Actual installation view >

- Improper product installation: Outdoor housing camera installed in the form of recessed mounting in the indoor ceiling
- The housing arbitrarily modified (laser processed) for camera installation in the form of recessed ceiling mounting on site
- The Fan noises from FAN operation along with the ceiling vibrating sound from loosened mechanical operating parts

- Be sure to check the product's purpose and manual before installing it, and arbitrary modifications are subject to limited service warranty.
- When selecting a product, refer to the Product Naming Rule on the website
- H: Housing models cannot be installed by recessed mounting in an indoor ceiling.

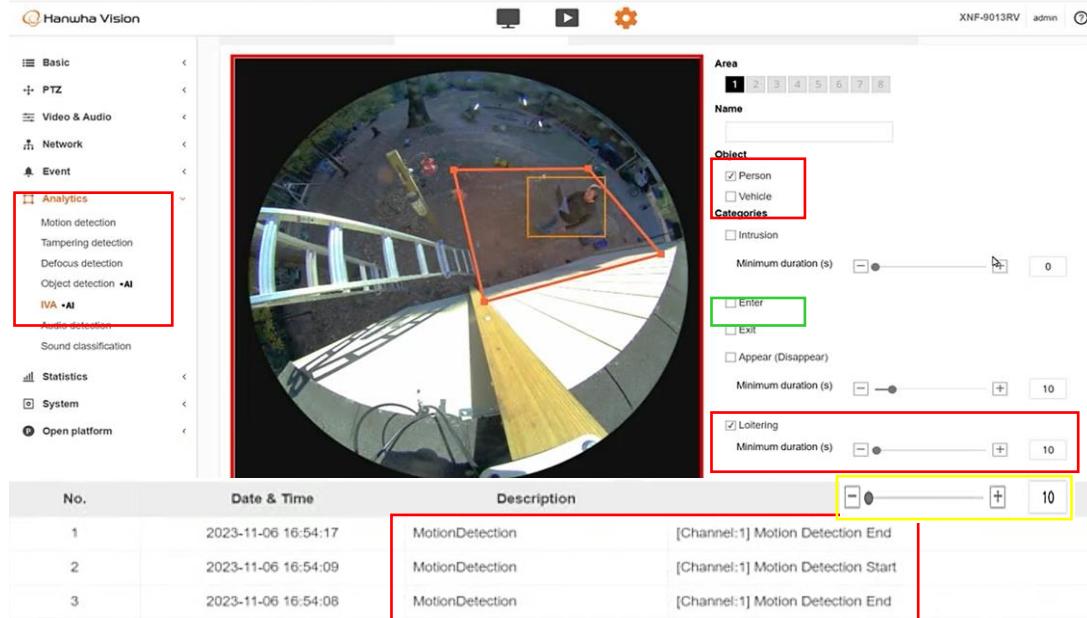
- Loitering detection was set by specifying the IVA area, but the event was not detected.
- Conditions: Object-Person, Categories-Loitering, minimum duration (s)-minimum value (10 seconds)
- Result: The event was recognized as 'motion detection' rather than 'loitering detection'.

- Since the object to be detected does not show its continuous movement, it does not meet the loitering detection conditions.
- In the following cases, the target loitering object became undetectable as the system considered it disappeared.
 - When the target object didn't move for a certain period of time
 - When the target object overlapped another object
 - When the environment was complex because there was a moving object in the vicinity of the target object

- Set both 'Loitering' and 'Enter' conditions for IVA

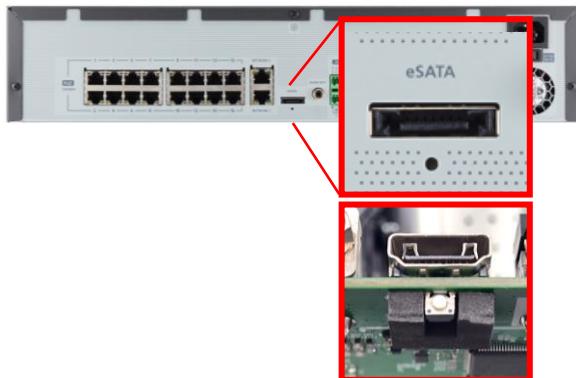
[Reset button on the back of the product]

- The [Password Reset] button on the back of the product was damaged by repeatedly pressing it with excessive pressure.
- The button can be considered to be damaged in the following cases:
 - a. If you do not feel the button being pressed when you use a tool to press the part where the reset button is located.
 - b. If you hear the sound of separated parts moving when you lift the product.

- Press the [Password Reset]] button with a sharp tip for about 15 seconds with moderate force.
- If there is no response when pressing the button with a tool, contact a designated repair shop for its repairs.

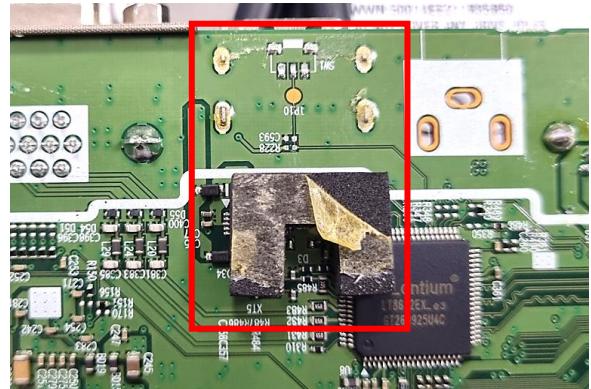
[Reset button broken and separated]

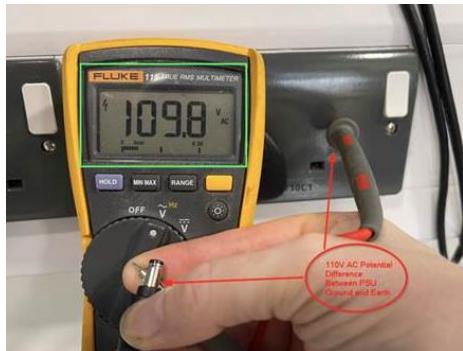
- There is a voltage difference between NVR Cover and building ground
- The neutral-to-earth voltage (NEV) is mistaken for leakage voltage

[NEV between Adapter Neutral terminal and GND]

- The NVR ground terminal was not connected.

- Follow the installation guide: Use the Ground terminal for ground connection.

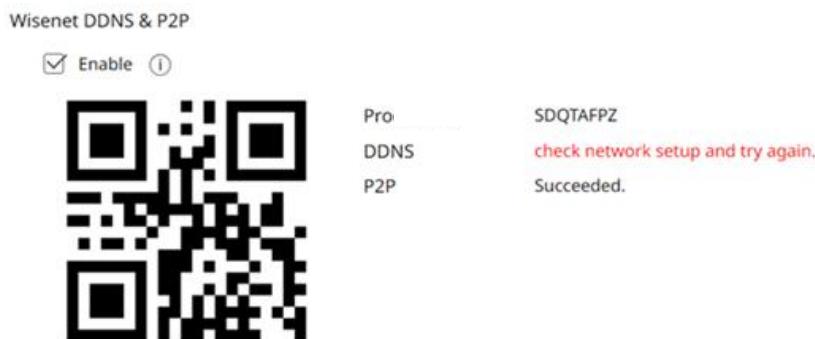
- The system was connected to the network, but DDNS was not accessible.

Quick connect(UPnP) Failed to find a router. Check the router's configurations.

- "Auto" used for NVR DNS server IP address + error in Router's DNS IP setting

- Precautions for DNS IP settings
 - ① Auto : Recheck the router DNS IP address
 - ② Manual: Set the correct DNS server IP address (e.g. 168.126.63.1 / 8.8.8.8, etc.)

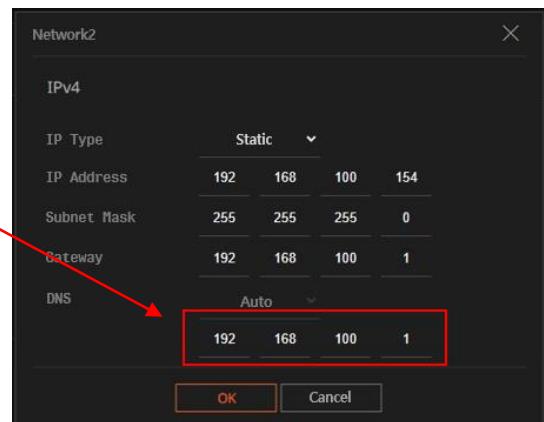
- (1) NVR DNS was set to "Auto"
- (2) Entered the Router DNS IP incorrectly.
- (3) The external domain was inaccessible
- (4) DDNS connection failed

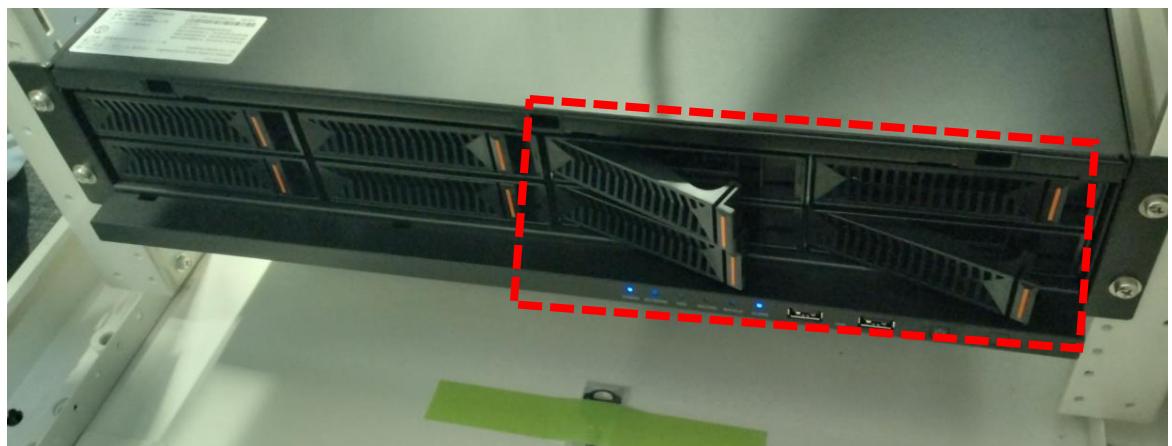
- The HDD wasn't detected, and the HDD bracket was open.

- The product was delivered with its HDD installed.

- When delivering the NVR product, pack and transport the NVR and HDD separately to prevent damage.
- Do not move the product with the HDD installed.
