Technical Newsletter

June.2024 Service Operation Team

Integrated front glass material for IR PTZ cameras

Guide for stainless camera exterior corrosion management

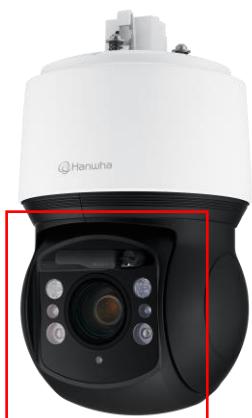
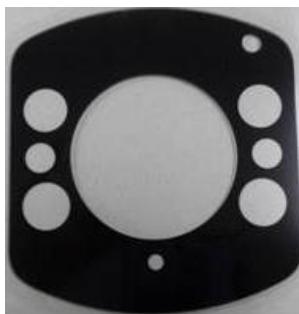
- 1) XNP-XX00RW (X-Plus)

- . Material code : FC37-001073B
- . Front glass feature: No ink on IR area

[No ink on IR area]

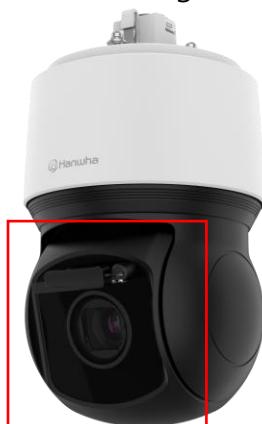
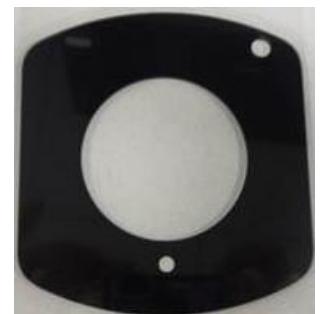
- 2) XNP-XX03RW (X-Plus AI)

- . Material code : FC37-001073A
- . Front glass feature: Black ink on all area

[Black ink on all area]

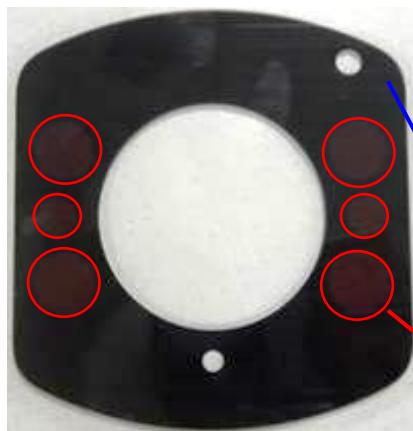
- **Integrated material for front glass_ X-Plus & X-Plus AI PTZ** (From Apr. 2023)

- Material code: FC37-001103A
- Front glass feature: Black ink + IR ink on IR area
- Advantages of using integrated materials
 - . Ensure design uniformity and improve appearance through the use of compatible materials
 - . Black ink is strongly resistant to IR light which enhances reliability
 - . IR ink improves light transmittance in the IR area while keeping aesthetic unity

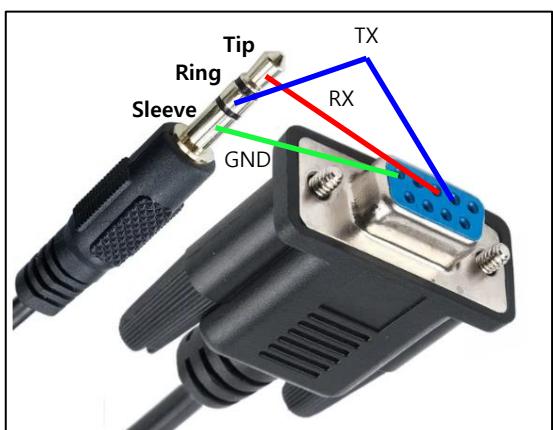
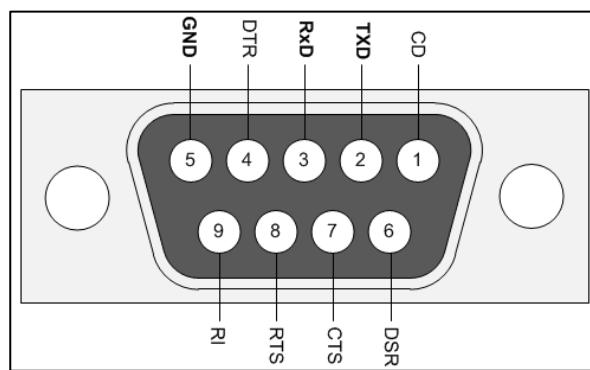
<RS232 DCE(Female) Pin alignment>

- Purpose of using Jigs :** To access NVR console log to perform remote review by a developer
- JIG supportive model :** Models with 3.5mm Console terminal(Audio jack) on the back of the NVR
- JIG 1. :** Audio jack cable (RS232 (DCE) to 3.5mm) that is connected to the NVR console terminal
 - Precaution when purchasing**
 - RS232 should be purchased as a DCE (Female) type and needs to check the Tx and Rx arrangement of 3.5mm terminals
 - 3.5mm terminals consist of Ring, Tip and Sleeve, and check the spec to see line alignment (Should be purchased Ring-Tx, Tip-Rx, Sleep-GND aligned product)

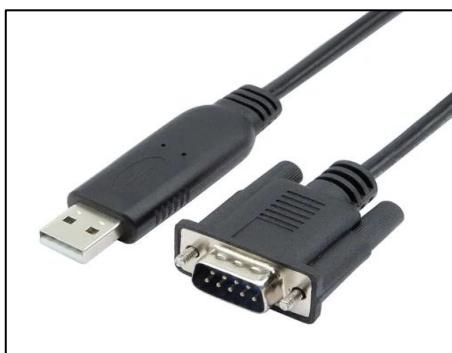
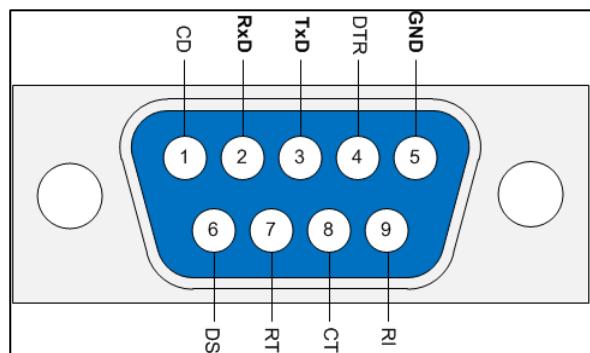
<RS232 DTE(male) Pin alignment>

- JIG 2. :** Jig1 is connected to jig2, and jig 2 shall be connected to PC USB port (USB to RS232(DTE))
 - Precaution when purchasing**
 - Purchase as RS232 DTE(male) type
 - Requires driver installation on PC: It is automatically installed on PC in most cases but sometimes it requires manual driver installation depending on the product

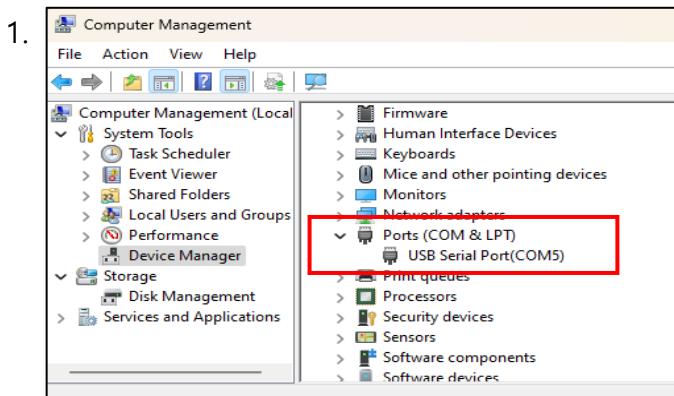
- Check the port connected to the PC:
If the driver is installed normally, it can be checked in the device manager
- The COM port of the jig is set as #5

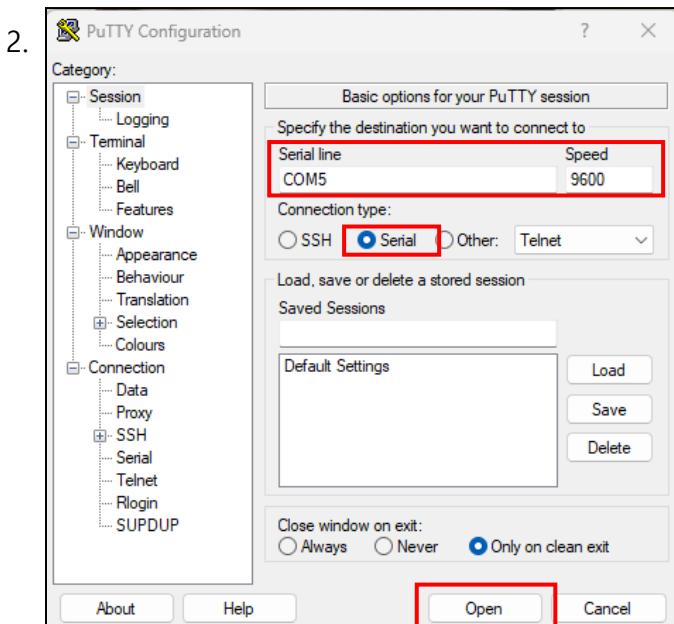
- Open a connection window in the terminal SW
- Connection Type : Select serial
- Serial Line : Insert COM Port number
- Speed : Remain default setting
. NVR : 115200
- Click 'Open' to open the terminal window

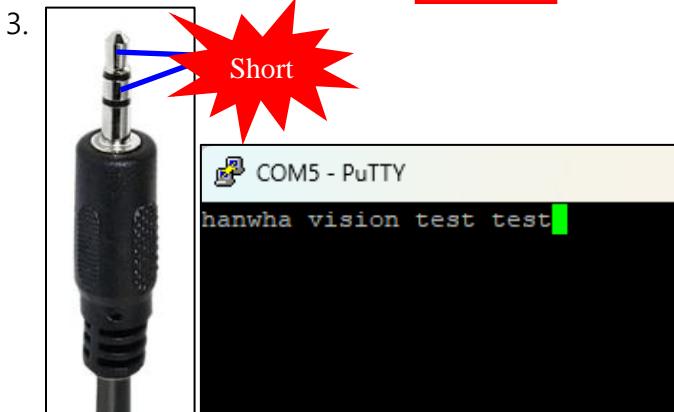
- Make a short for Ring and Tip of the 3.5mm terminal
- Enter letters using keyboard while remain short
. When letters appear : OK
- . When letters not appear : NG
Need to check JIG and connection settings
