Technical Newsletter

September 2024 Service Operation Team

Instructions for Sleeve Fan Replacement

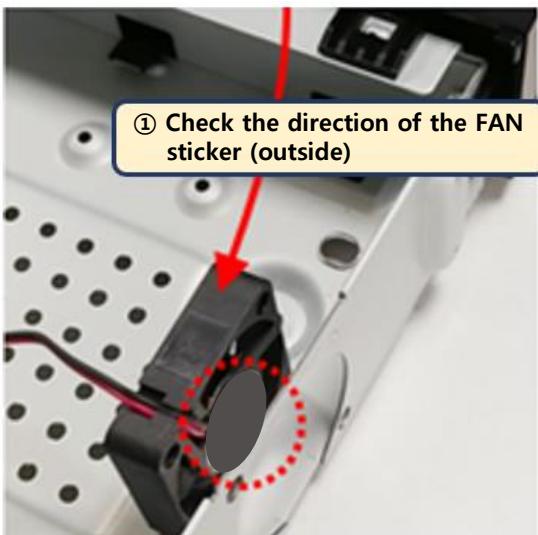
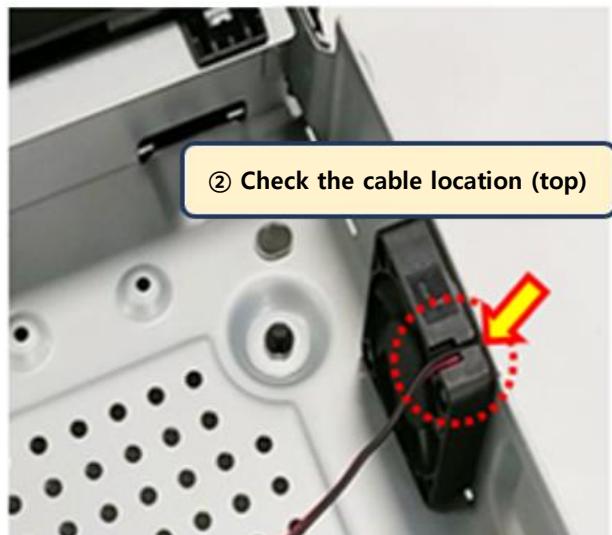
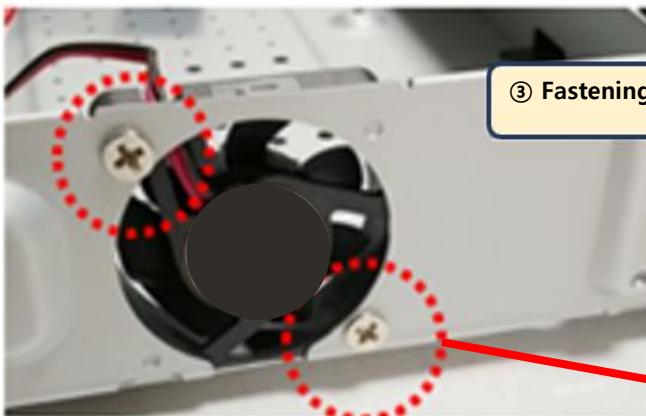
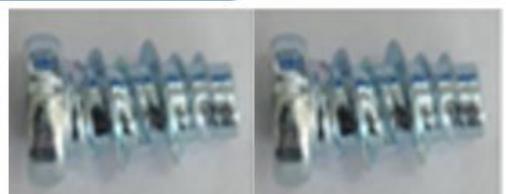
. To disseminate precautions against cases of fan component deformation and noise generation due to use of non-standard screws and excessive tightening of screws.

Using screws of different specifications and excessive screw tightening can cause deformation and noise in the fan.

④ Fasten the screws in two diagonal locations

- Use genuine parts (Screws, Fan)
- Do not excessively tighten the screws for fixing the fan.

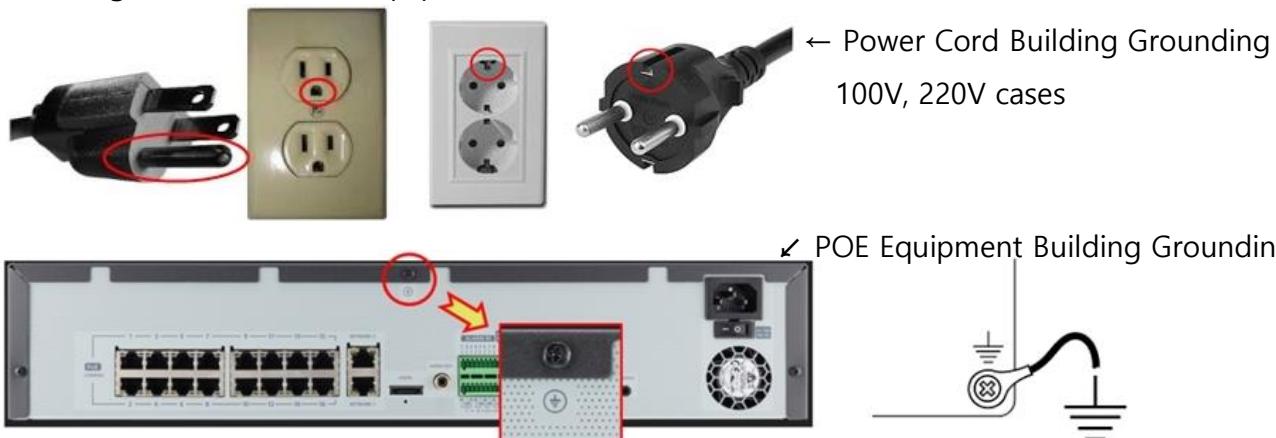
- ① Grounding outlets and POE equipment

- To guide the Surge Protection method when installing network cameras on site
- . In the summer, lightning strikes are frequent; thus, there are frequent POE power supply and camera failures caused by electrical surges.

To prevent electrical surges, it is necessary to take measures such as grounding, using STP cables, and installing surge protectors.

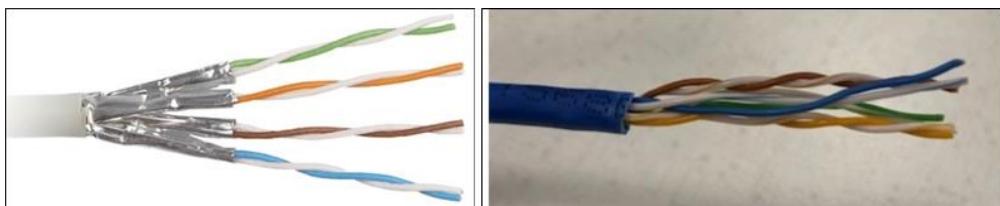
- ② Recommended use of STP cables

[STP LAN Cable: Surge Protection(O)] [UTP LAN cable: Surge Protection(X)]
