Technical Newsletter

April 2025 Service Operation Team

Improvements to the forced rotation of camera Vandal Dome covers

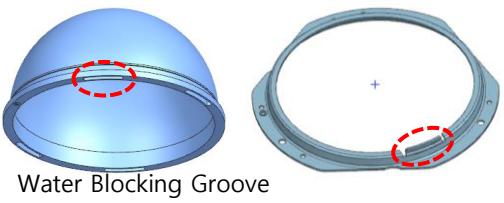
No	How to improve	Images
1	<ul style="list-style-type: none"> ➤ Utilize the dome cover's water-blocking groove → Insert the rib into the water-blocking groove <ul style="list-style-type: none"> - Q VF (6082R series) : QNV-6082R, QNV-7082R, etc. - Q VF (general), AHD, L, A QNV-8080R, HCV-6070R, LNV-6072R, etc. - X VF Indoor Vandal / X VF Indoor : XND-6080RV, XND-6080R, etc..

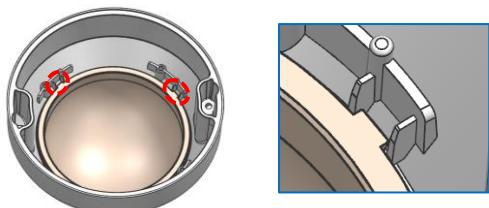
3	<ul style="list-style-type: none"> ➤ Assemble the protrusions of the dome cover between the CASE-TOP ribs. <ul style="list-style-type: none"> - 12x Vandal : XNV-6123R - Q AI Fixed : QNV-C8013R, QNV-C8023R - X Fixed Vandal : XNV-6020R, XNV-8020R, etc. - Q, AHD Fixed Vandal : QNV-6012R, HCV-7010RA, etc. - L, A Fixed Vandal : LNV-6012R, ANV-L7012R, etc.

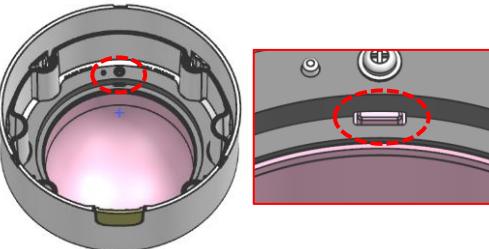
4	<ul style="list-style-type: none"> ➤ Assemble the protrusion on the dome cover into the groove on the bracket. <ul style="list-style-type: none"> - Q AI VF : QNV-C9083R, QNV-C6083R, etc.
