# Technical Newsletter

July 2025 Service Operation Team

Information on changes to IR WINDOW (XNP-Cxx03RW series)

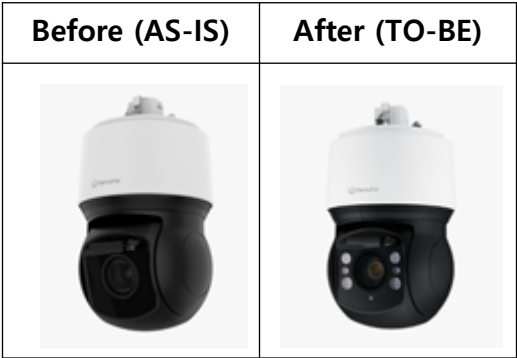
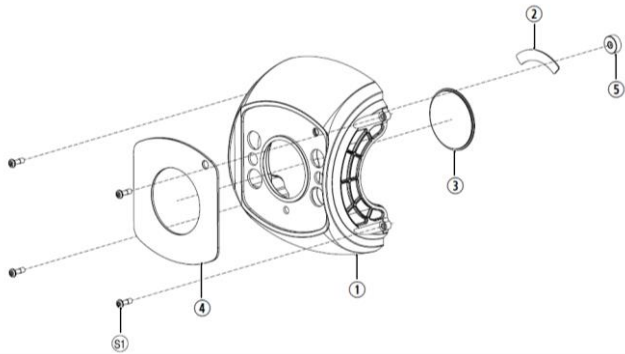
- Due to discontinuation of IR ink, the exterior cover has been restored to its original design (IR ink removed).

| Part Location | Material Number | Item Name | Remarks |
| 4 | FC37-001103A | WINDOW-IR_XNP-XX03RW | Before |
| | FC37-001073B | WINDOW-IR_XNP-XX00RW;BLACK | After |

- Backward-compatible change
- The simple design change causes no difference in performance/function,
