Technical Newsletter

May 2025 Service Operation Team

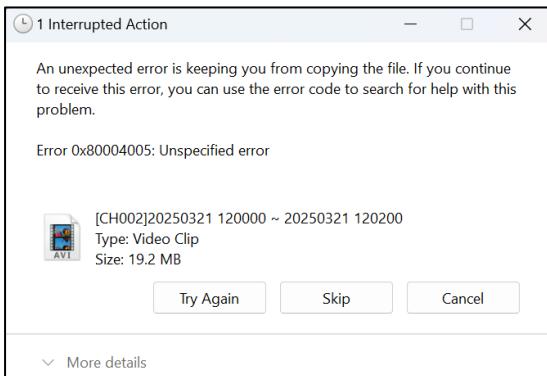
- **Password setting has been changed to a mandatory requirement for selecting a web viewer backup file as a ZIP type.**
 - . You cannot unzip ZIP files with Winzip.
 - . You can use a decompression program that supports the encryption algorithm (AES-256).

[Unzip failed]

- **To decompress backup files, we recommend you to use Bandizip/EasyCrypt/7-Zip tools supporting the AES-256 algorithm.**

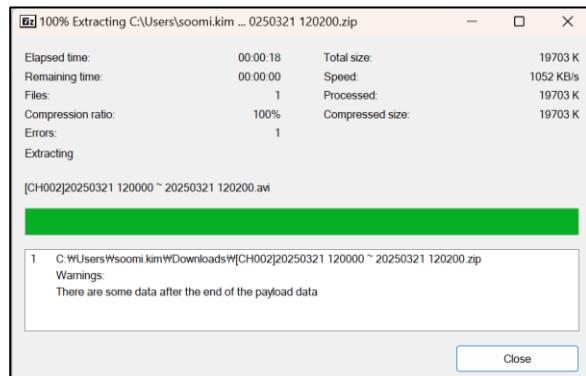
[Unzip succeeded]

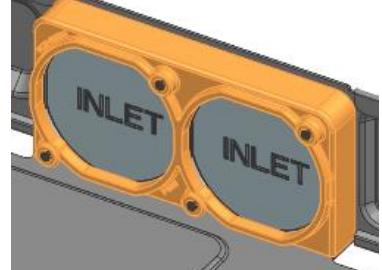
| Types | FAN Holder (Single) | FAN Holder (Dual) | Remarks |
|---|---|---|---|
| Holder appearance | | | Compatible with existing FAN/Case |

- Adding Holder parts to solve the problem of damage and noise caused by the stress of Sleeve FAN fixing Screws.

- Holder parts can be used for products (market products) where the holder is not applied.
 - . Single Fan : FAN(1EA) + Holder(FC29-018204A) + Screw(Z6002002701A)-2EA replacement
 - . Dual Fan : FAN(2EA) + Holder(FC29-018205A) + Screw(Z6002002701A)-4EA replacement
