Technical Newsletter

October 2025 Service Operation Team

Software update due to MD IC change (BOX CAMERA)

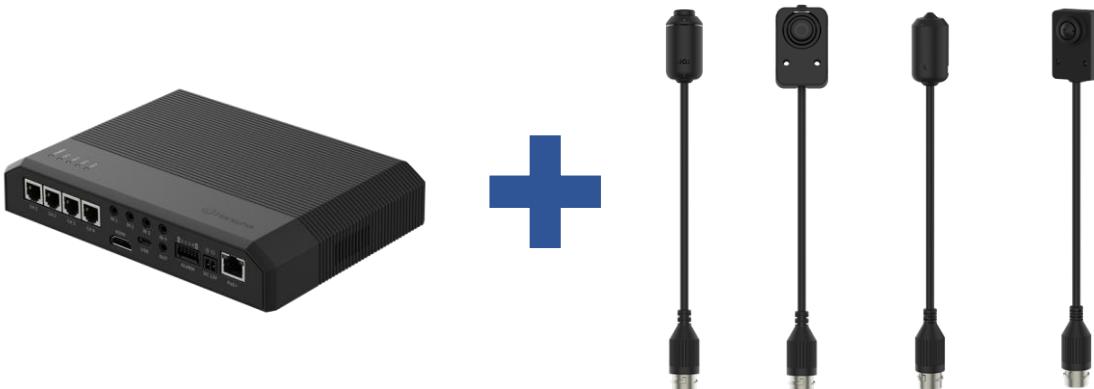
1) If no video is displayed after applying a 5MP lens, verify that the camera firmware is up to date.

(2) When connecting a 5MP lens while accessing the PNM-C2000QB webpage, privacy mask(s) may misaligned.

**Firmware v25.02.00 or higher is required.**

Refresh the webpage after connecting the lens.

When replacing a 2MP lens with a 5MP lens, privacy masks must be repositioned.

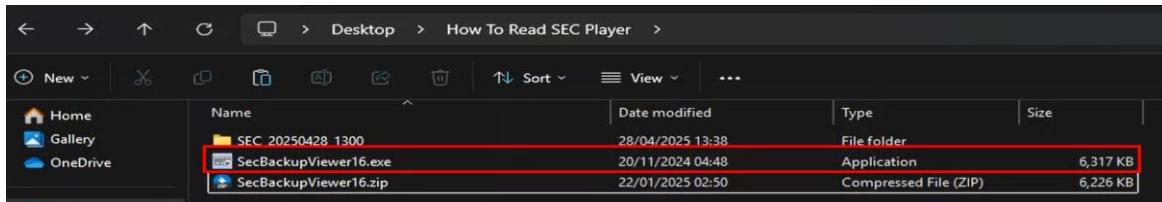
- To provide a workaround for cases where video playback fails in SEC Backup Viewer due to player compatibility issues when using an Intel 12th generation or later CPU with integrated GPU

Step 1. Download SEC Backup Viewer16 and extract the files.
