May 2023

Technical Newsletter

May Contents

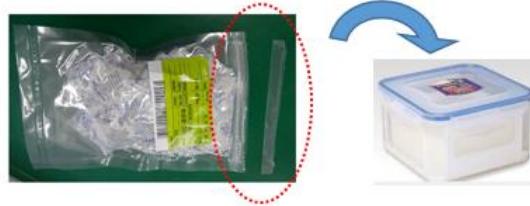
※ Bulk packaging(50pcs)

- Check the color of 'HUMIDITY INDICATING': Green(Good to use), Purple(Needs to be disposed)
- Store DesiKhan in airtight container after opening the packaging (Dispose after 24hrs)

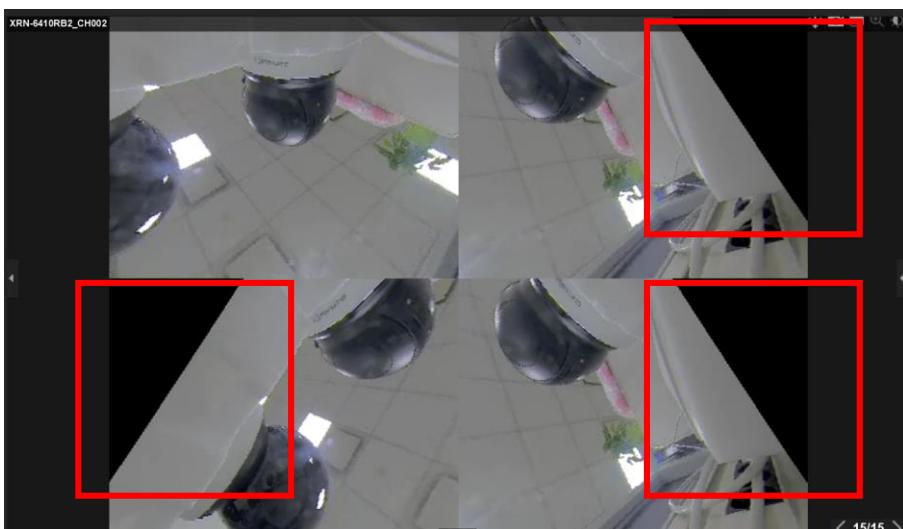
5. Check point

- Fisheye camera's default mounting mode is 'Wall'
- Mounting mode should be adjusted to fit to installation environment
- If not adjusted properly, dewarping view can be displayed as below scene

4. How to set mounting mode

- Configuration → Device → Registration → NVR registered camera → Camera info → general
