# Technical Newsletter

April.2024 Service Operation Team

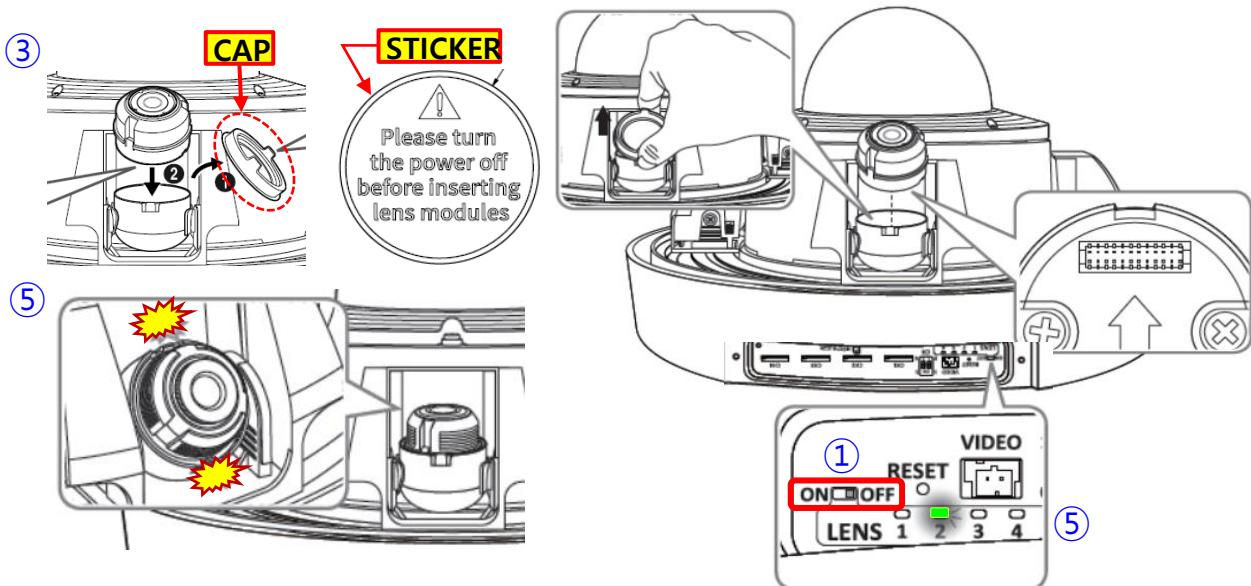
## Guide for multi-channel camera lens module replacement

! 1. Removing and inserting the lens module without turning off the power may result in a board failure  
2. PTZ calibration error occurs if any of all four lens is flipped  
3. Avoid touching the lens separately, as it is shipped from the factory with the focus adjusted during the manufacturing inspection.

- 1) Make sure power is not connected(HPoE) and the power switch is 'OFF'
- 2) Remove defected lens module
- 3) Remove the cap from the lens module and insert the lens module align with the connector until it hooks properly with 'Click' sound
  - Make sure all four channels are not flipped
- 4) Turn the power switch 'ON' and connect power(HPoE)
- 5) Check if lens module is attached correctly, the lens module status light will illuminate green
  - If the lens module is not attached correctly, the lens module status light will illuminate red
