# Technical Newsletter

July 2024 Service Operation Team

## Jello effect in camera video (Rolling shutter)

# Camera installation direction and bushing use method

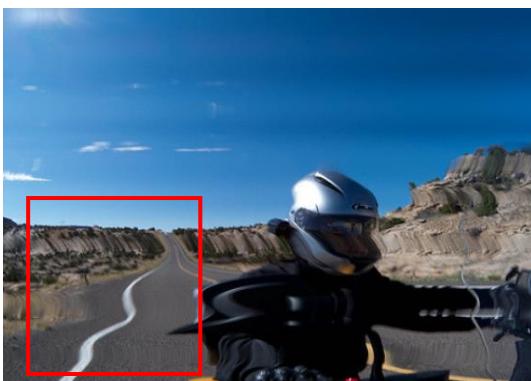
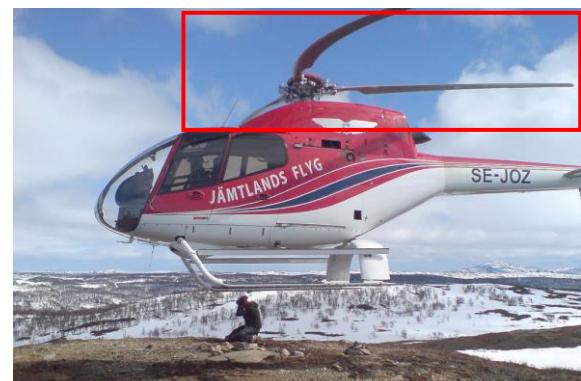
- Parts of the frame become blurred, or straight lines appear crooked
- In the video, it is expressed as a rising haze or a jelly-like vibration.

- This is a phenomenon that inevitably occurs in cameras that use a rolling shutter type image sensor.
- Rolling Shutter is a method of sequentially shooting the entire screen line by line when shooting individual frames. There is a time difference in the shooting of each line; thus, image distortion occurs in situations where there is a fast-moving subject or the camera is moving quickly.

- Lower the Shutter Maximum little by little and maintain the set value at the point when the phenomenon is alleviated.
- However, if the exposure is prolonged by slowing down the shutter speed, diffraction or saturation may occur due to the influence of the aperture. Thus, caution is required.
