Technical Newsletter

March.2024 Service Operation Team

PT(Pan/Tilt) limit of PTZ camera

Installing Wisenet Wave server on Solidedge SSD

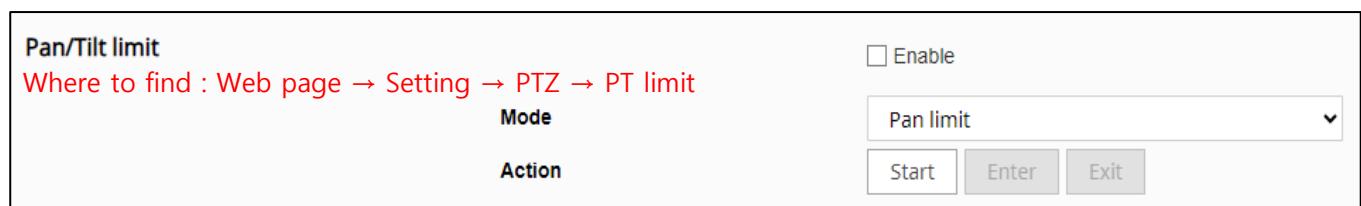
● PT (Pan/Tilt) limit

- It is a feature to set a excluding area of PT action, PT action only runs except the limited area
- It is a user convenience feature which to limit the area where does not require monitoring when using a Jog shuttle
- Default value is off, select [Enable] option to use the feature(Refer to Online Help)

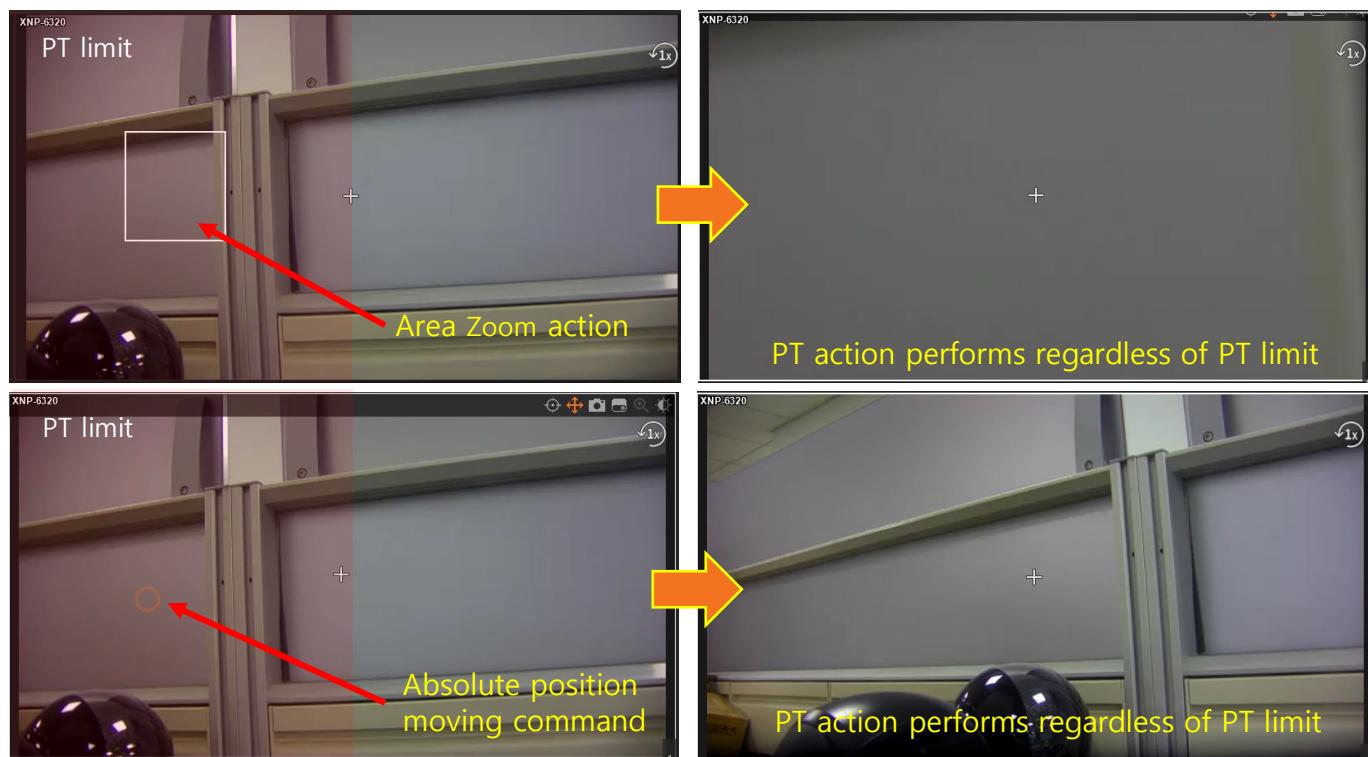
● Examples of exceptional case

● Exceptional case of PT limit

- Sequence action(Preset, Swing, Group, Tour, Tracking, Auto run, Home)
- Area Zoom and Absolute position moving command(Mouse click to move from VMS and NVR)

PT limit feature is used for a user convenience purpose, not for a privacy limit
Please use 'Privacy Area' for area restriction for privacy security purpose

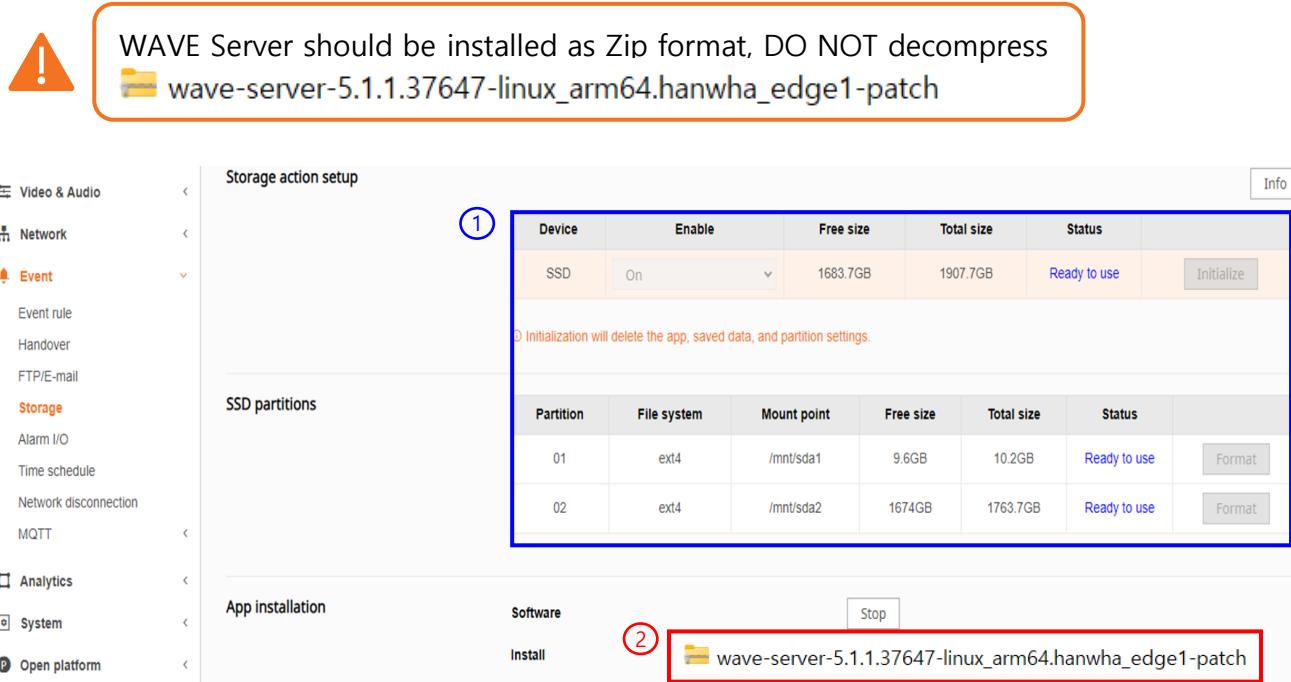
- WAVE server of Solidedge camera is embedded on SSD
- WAVE server should be reinstalled after SSD format or replacement of SSD to repair

- ① Check SSD capacity and status
- ② Website → FW file download/decompress → find WAVE Server zip file (DO NOT decompress Zip) → Camera web → Event → Storage → App Installation → Install WAVE

- Enter License Key after re-installing WAVE Server
- In case of missing License Key information, please contact HQ CS Tech support
