# Technical Newsletter

August 2025 Service Operation Team

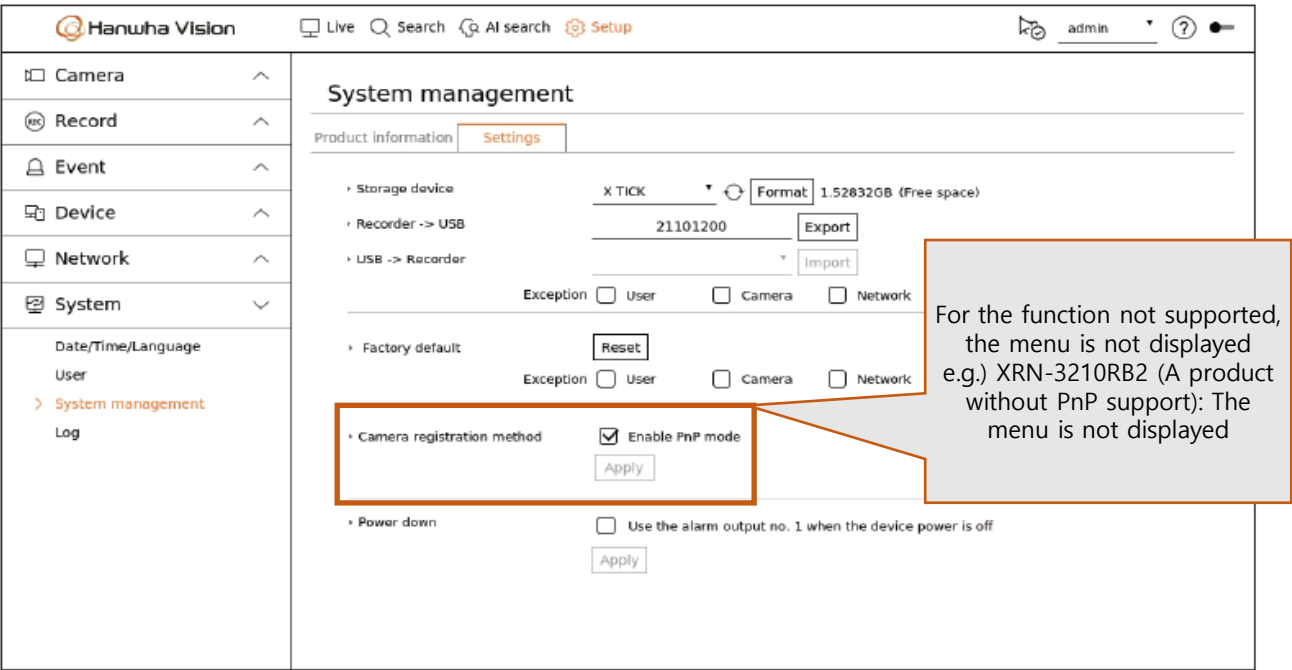
### ● Misrecognition case

- Camera registration method: The **"Enable PnP mode"** menu to be used did not appear in the NVR menu.
- PnP mode = Cameras connected to the PoE port are automatically registered to the channel in the order of the port number.

- **[Camera registration method: PnP]** is a function **provided only for products that support PoE**.
- For products without PoE support, the corresponding menu is not displayed and the PnP function is not provided.
- For PoE support, please refer to the "Supported functions by model" page in the User Manual.
