Technical Newsletter

February 2025 Service Operation Team

Rebuilding time by HDD capacity

Specifications for resolution change when using AI camera DPM function

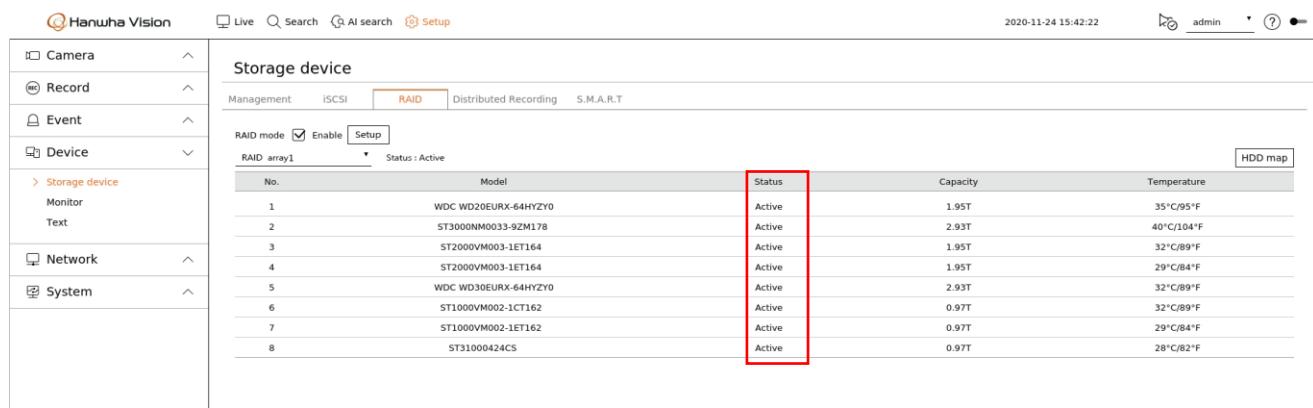
※ While the HDD is rebuilding, its status is displayed as 'Rebuilding'.
