# Technical Newsletter

March 2025 Service Operation Team

## How to resolve 'SSM License Active' failure and Clone detection

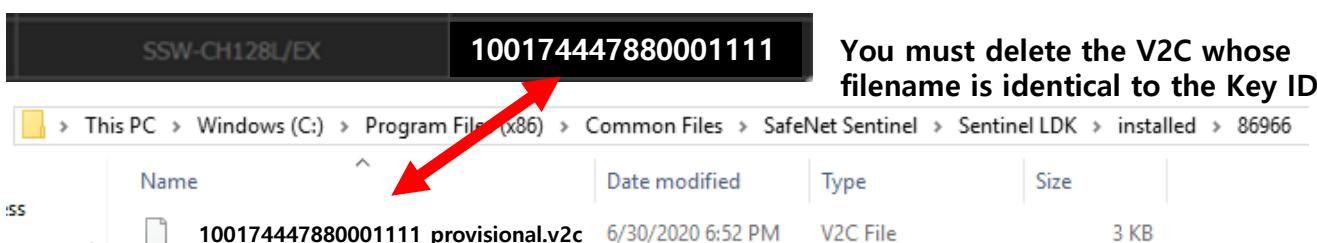
### Case 1) When a paid license is not activated

- Even though a paid license purchased by a customer has been registered, its status does not change to Active.
  - . Reason: If the number of the Trial (Free) License channels is greater than that of the Paid License channels, the paid License becomes active after the Trial period ends (Product Specifications)

### ● Solution: How to delete the Trial(Free) License

- 1) Go to the file path where the license is stored.

※ License File Path: C:\Program Files (x86)\Common Files\SafeNet Sentinel\SafeNet Sentinel LDK\installed\86966

- 2) Find the V2C file whose filename is identical to the Key ID.
- 3) Delete the V2C file.
- 4) Then restart the service.

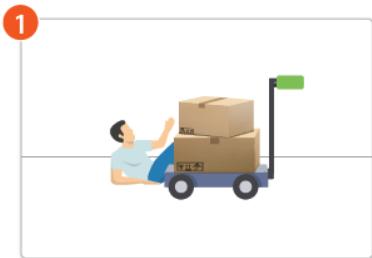
① When the person's body is partially or completely covered by an object

(Part of the body covered by an object)

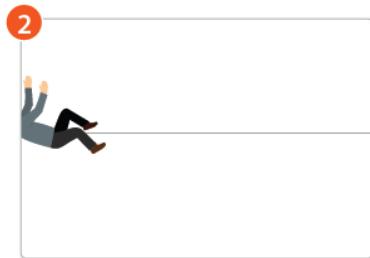
② When the target (person) is not visible on the screen

(Part of the body has moved out of the camera screen)

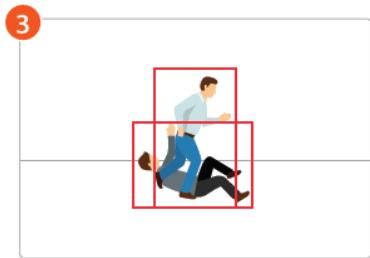
③ When another person who overlaps with the target person on the screen falls down

(Overlapping with others)

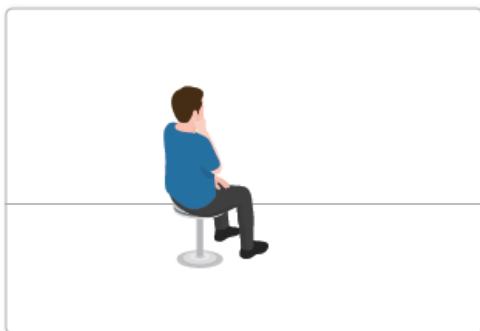
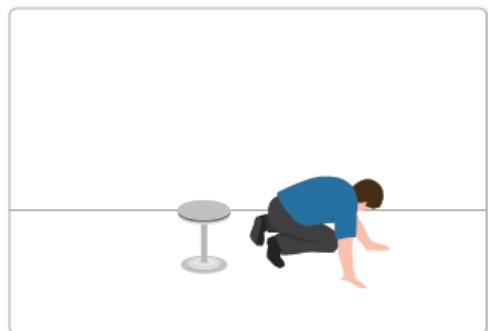
2) When a person falls while not walking

- The slip and fall detection function is designed to detect a person who falls while walking.

Therefore, if a person falls while sitting or bending for more than 3 seconds, he/she may not be detected.

('Sitting' for 3 seconds or more)

(Falls down afterwards)
