2023 Installation Failure Cases

Service Operation Team 2023.12.13

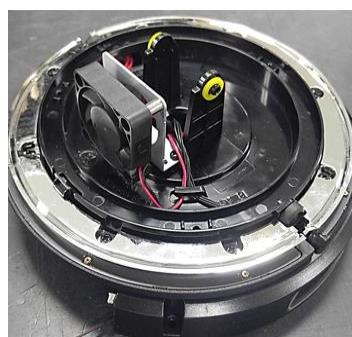
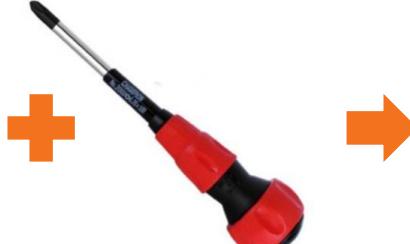
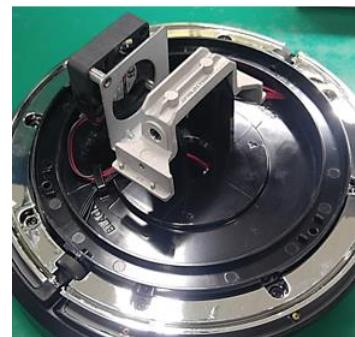
PTZ camera automatically initializes its focus everyday

- Camera automatically operates tilt down, zoom in/out, focus adjustment, preset movement at a certain time once a day
- The screen looks noisy and seems like showing one color

- Automatic lens initialization was set as 'Once a day'
- While performing lens initialization, it zooms in to max level thus one spot is enlarged too much so that the scene looks like showing only one color
- Video and Audio > Camera Settings > Focus > Lens Initialization

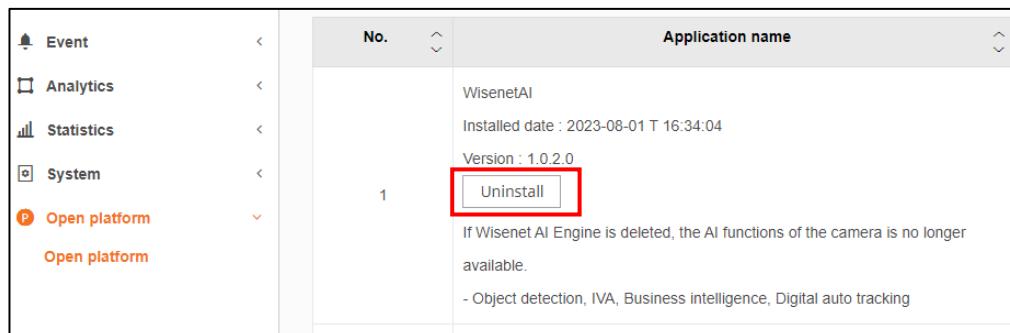
- Open platform > WisenetAI App deleted
- FW update attempt failed in unstable network environment

- Wisenet AI App manual installation (App location : website PNO-A6081R product page > Firmware)
- How to : Camera web → Setup → Open platform → Select file

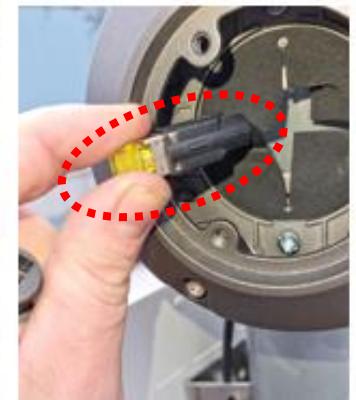
- Moisture appears repetitively on camera front cover even though Desikan has been replaced

[Gasket & butyl tape missing]

4. Measures

- Comply with the installation guide
 - . Apply RJ45 connector waterproofing Kit
 - . Apply butyl tape for waterproofing

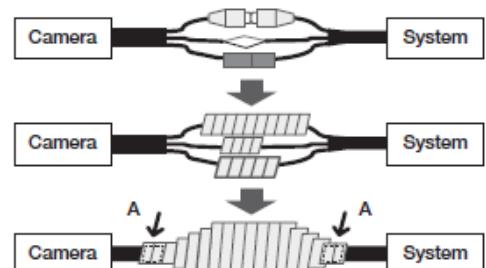
[Short prevention-Independent insulation]

- Arbitrary device change: Cable cutting and cladding
- Damage to camera power supply part, short between cut cables

- Avoid arbitrary disassembly or deformation
- Apply insulation to unused cables
 - . Separate insulation should be applied to each cable

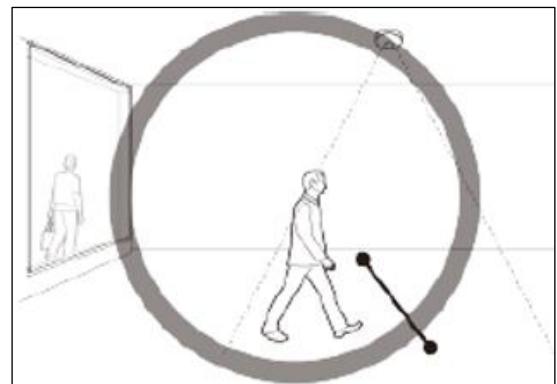
- Installed the camera using Stand type pole and run the IVA people counting but failed

- Comply with guideline : Online help AI page
- . Secure enough camera view angle
- . Avoid locations affected by strong light, such as sudden lighting changes, direct sunlight, sunsets, and sunrise
- . People counting purpose camera should be installed at ceiling

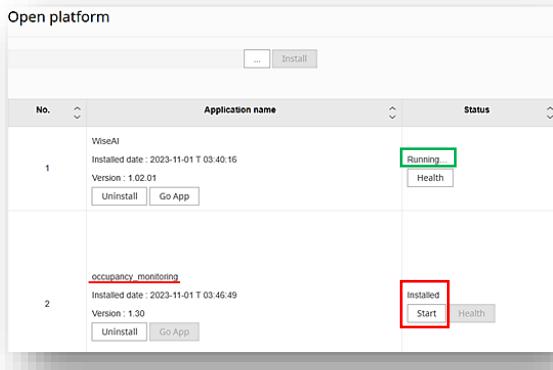
[OMA Installed/ Before running]

Cause1. Compatible FW versions are not matching between Camera and OMA

Cause2. OMA is not running, app and camera counting information was not initialized when setting is changed
