Aug. 2023

Technical Newsletter

Aug. Contents

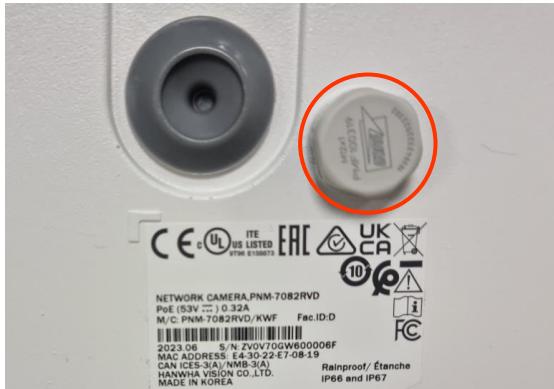
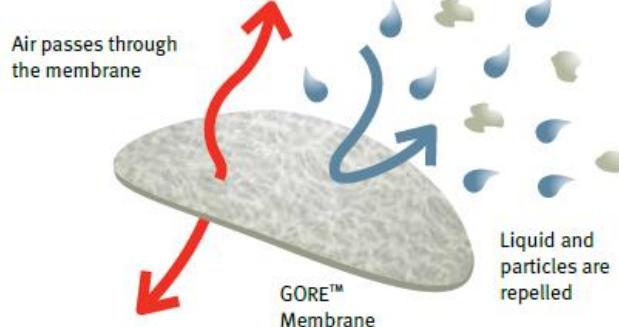
Breathable Barrier Protection

- By applying Gore Vent, product air permeability is increased to maintain internal and external pressure balance, prevent penetration of contaminated particles, and minimize condensation. Do not attach desicants to products applied with Gore Vent
