Installation failure cases in 2024

Service Operation Team 2024.06.30

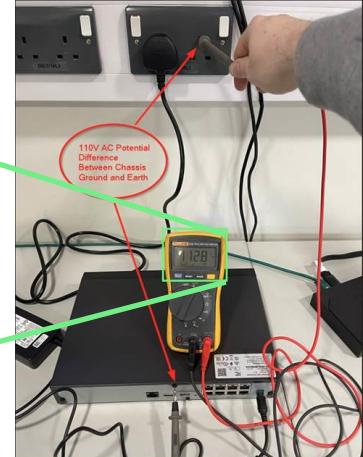
- There is a voltage difference between NVR Cover and building ground
- The neutral-to-earth voltage (NEV) is mistaken for leakage voltage

* Neutral-to-Earth Voltage: It is an invalid power voltage caused by the potential difference between the neutral terminal and the earth when the earth is not connected (this phenomenon is not a defect in the product)

- The NVR ground terminal was not connected.
