# Technical Newsletter

August 2025 Service Operation Team

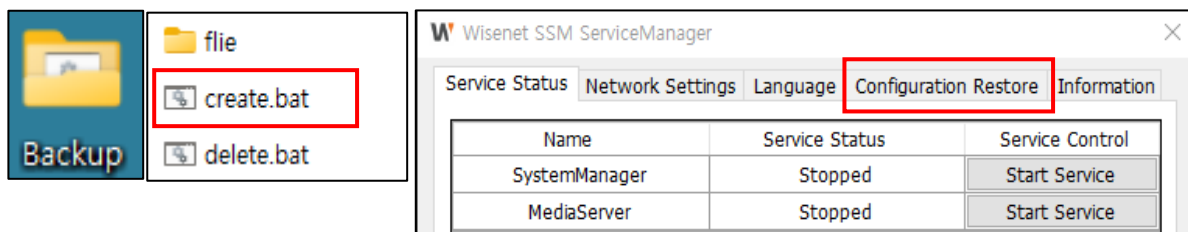
- Download the **backup.zip** file from **No: LI-202507210022**, a post on the Information Plaza site, and unzip it
- Create a **Configuration Restore** tab: Double-click '**create.bat**' → Exit **ServiceManager** → Start **ServiceManager**

※ Note: Be sure to unzip the file to the desktop.

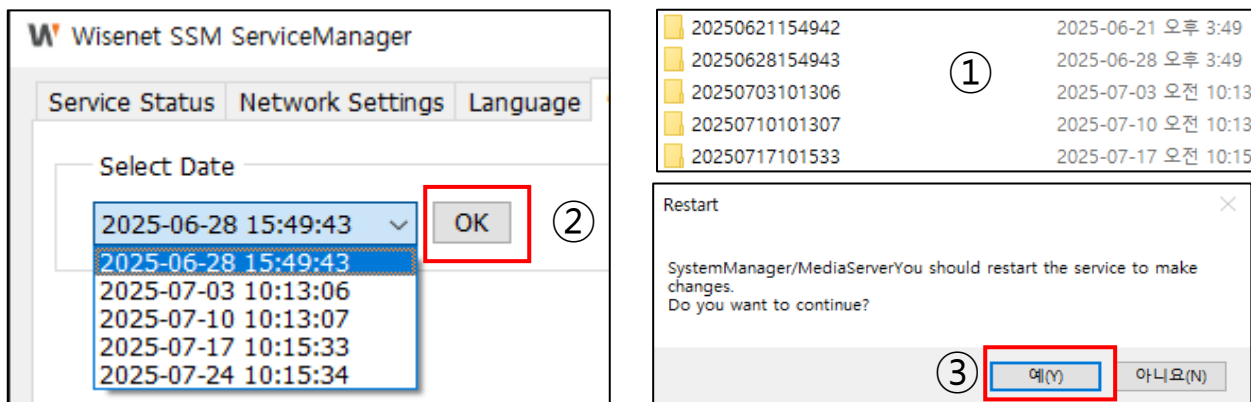
- ① The date for **Configuration Restore** matches the backup file in the **SSMBackup** folder.
- ② Select a date in **Configuration Restore** and click the **[OK]** button
- ③ When the restart guide pop-up appears, click the **[YES]** button

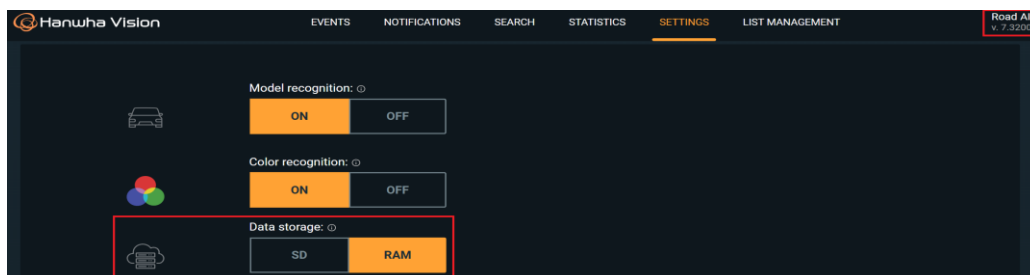
- After reinstalling the APP in the RAM storage set to default mode, it is necessary to change the mode to **SD** mode once for the first time.

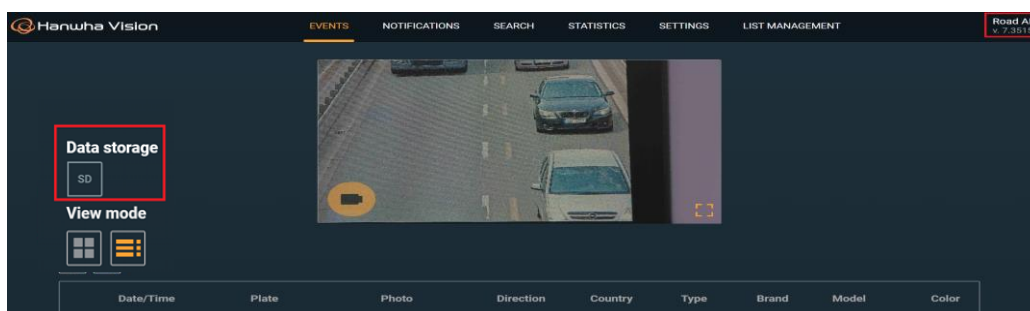
- SD card/RAM storage mode support

. **SD** card mode: For the camera-only use, image storage/preservation is possible.

. **RAM** mode: For the VMS-linking use, license plate images and videos can be checked in VMS, but image preservation is not possible.
