# Technical Newsletter

FEB.2024 Service Operation Team

## Understanding camera lens focal length and magnification

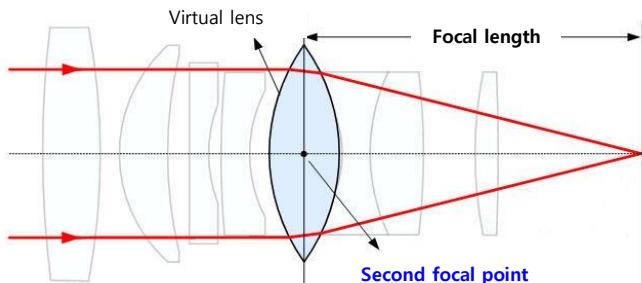
- The focal length of a compound lens, composed of a series of simple lenses, is the distance from the **second focal point** to the image sensor

#### Second focal point?

It is a point on the principal axis, such that rays coming parallel to the principal axis after refraction through the lens actually meet here

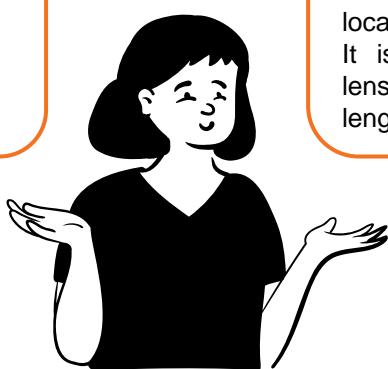
**Q2. How come the focal length is longer than the camera body length?**

The second main point can also be located outside the lens. Telephoto lenses are designed in such a way that the second main point is located outside the lens. It is mostly applied to telephoto lenses because it can reduce the length of the lens.
